# District 3 Maintenance Needs

Ormond Oaks Canal

Schexnaydre Lane CN RR culverts

Ormond Place Headwall and Channel

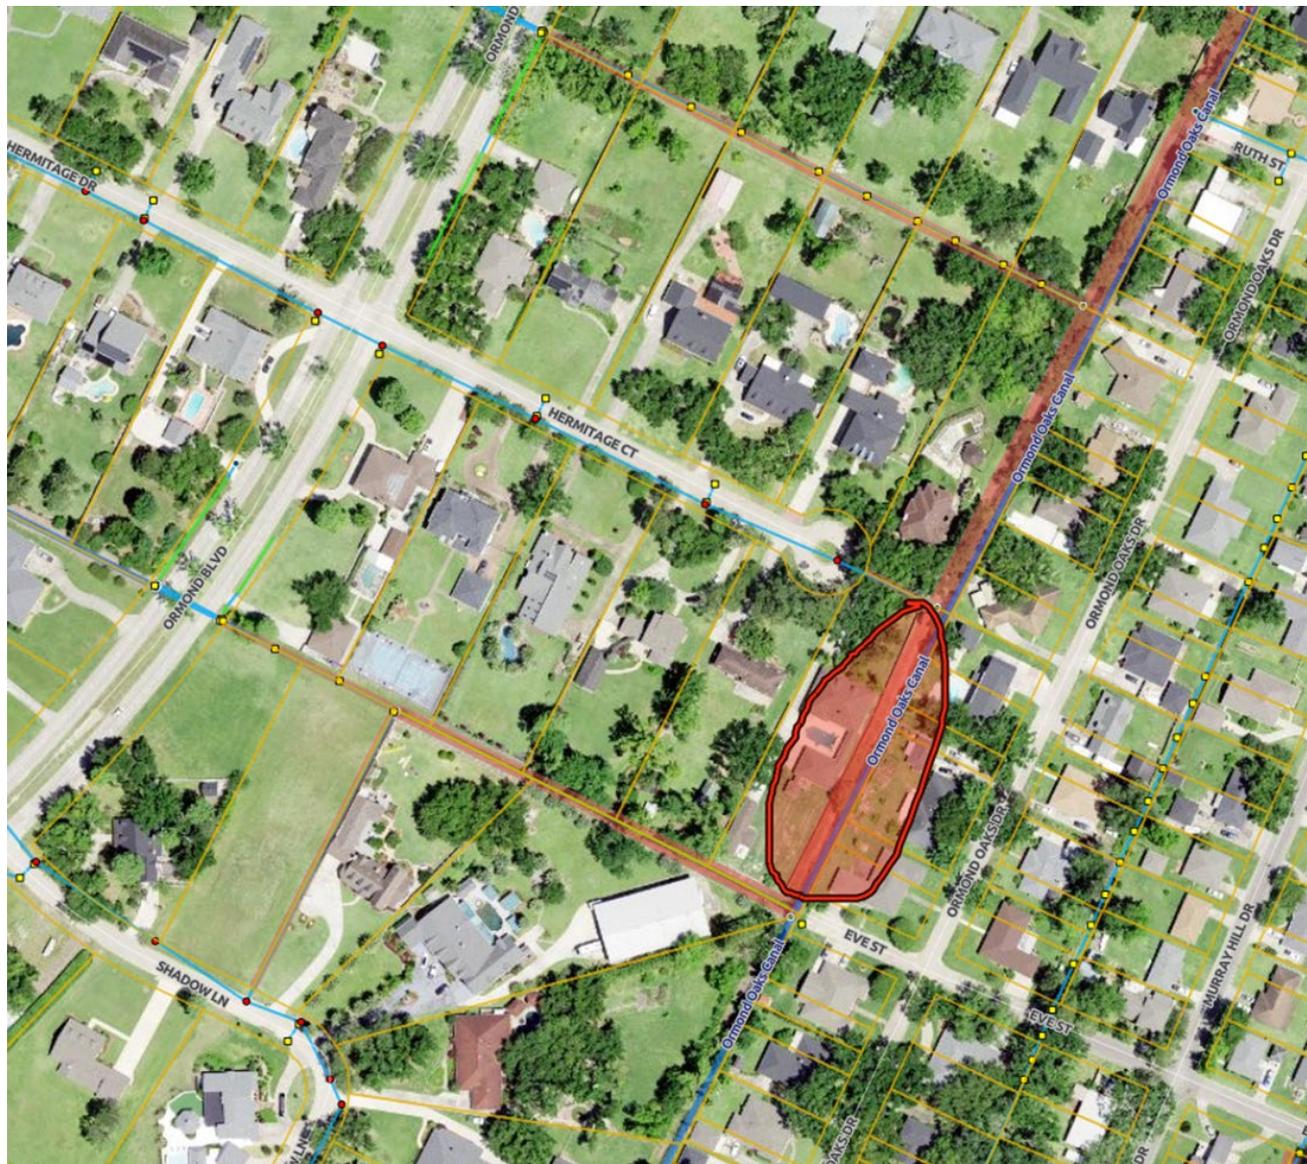
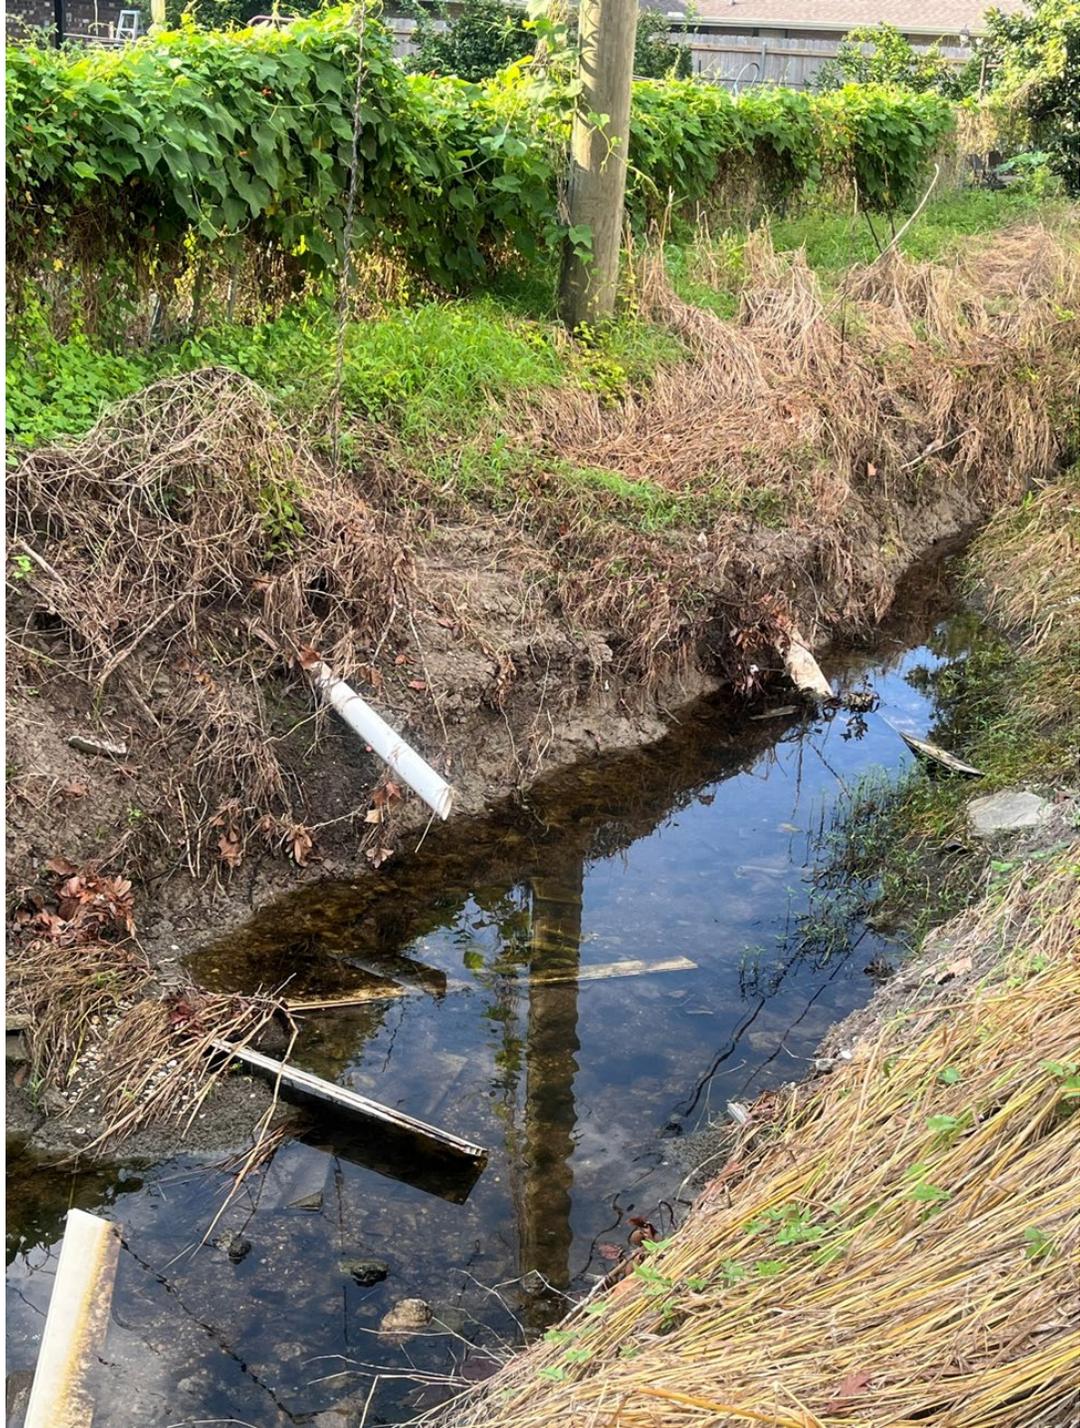
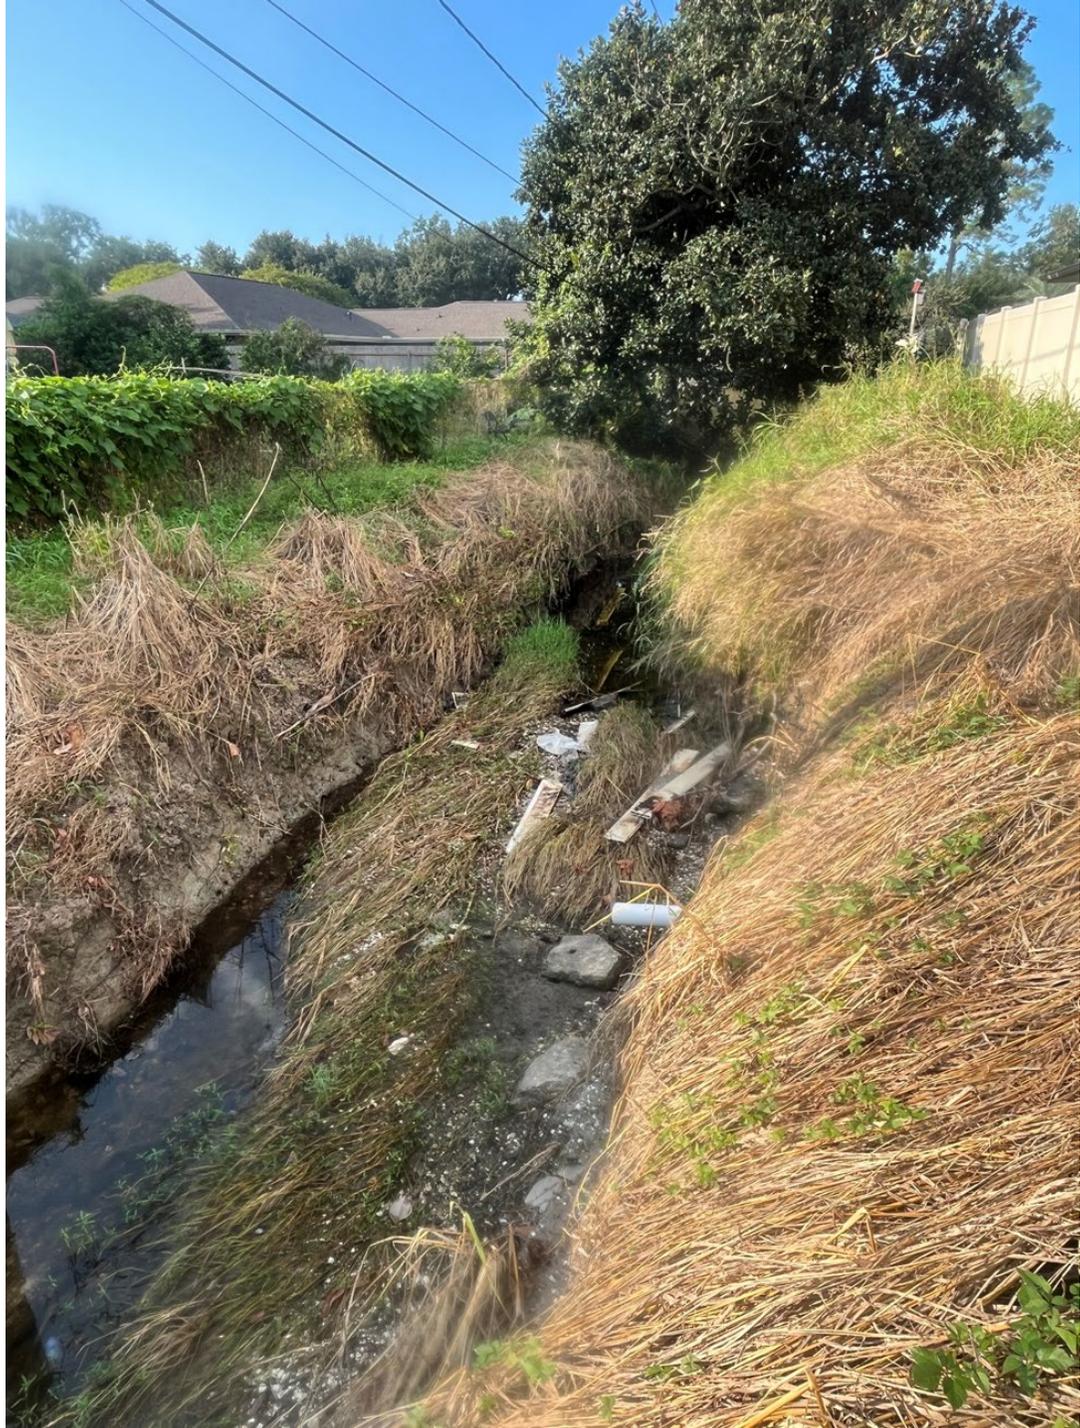
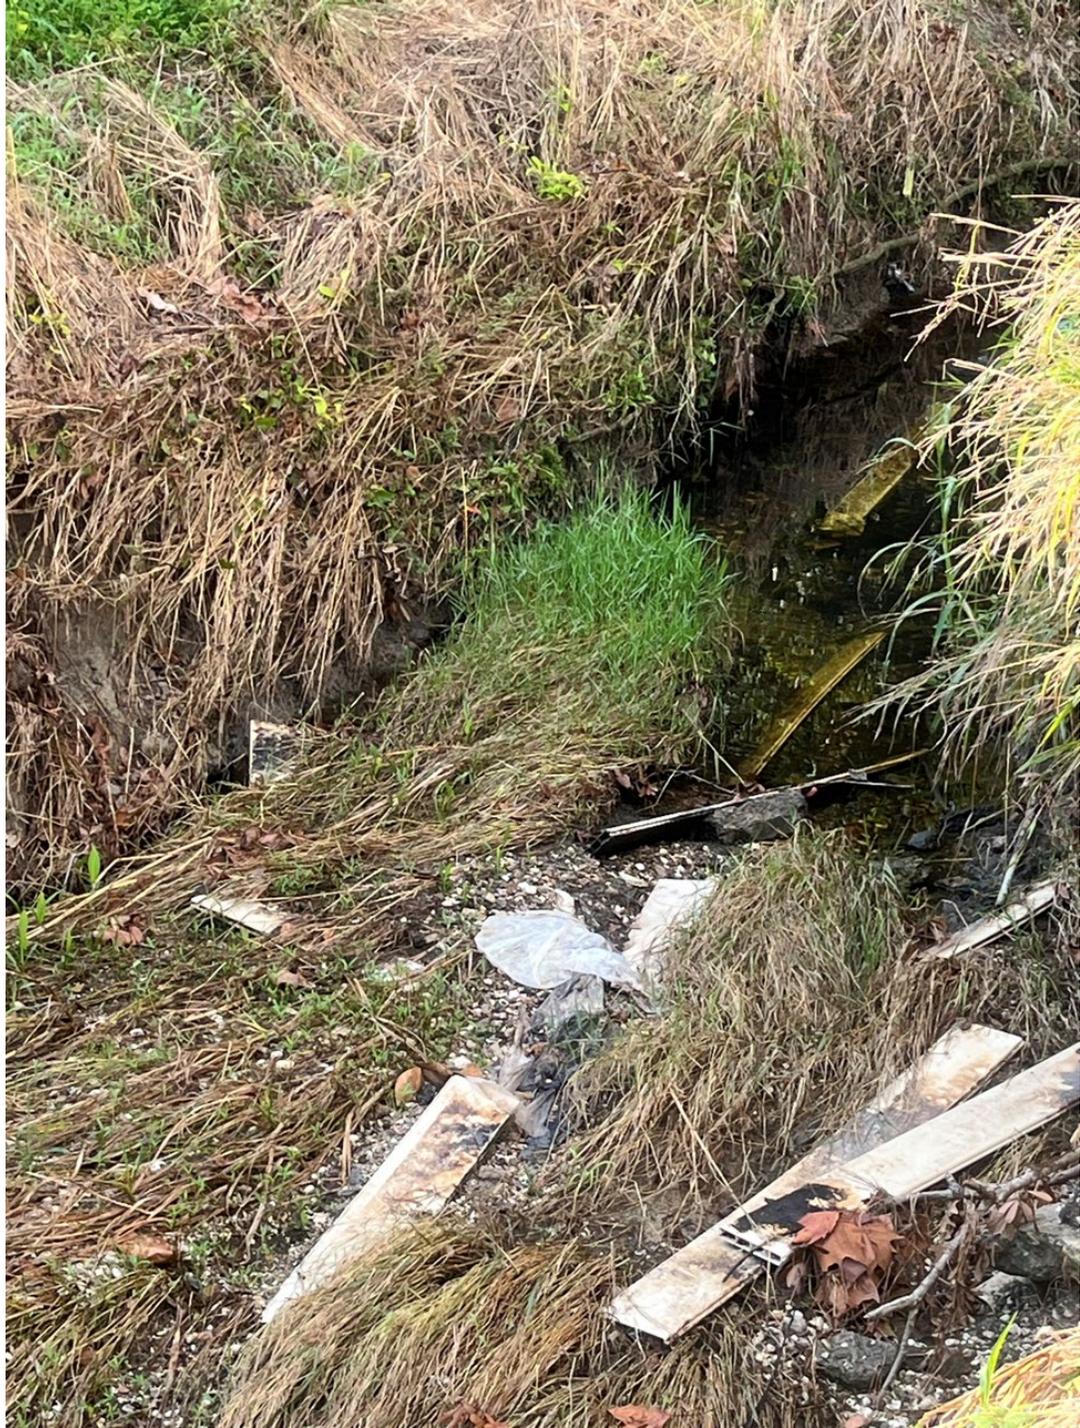
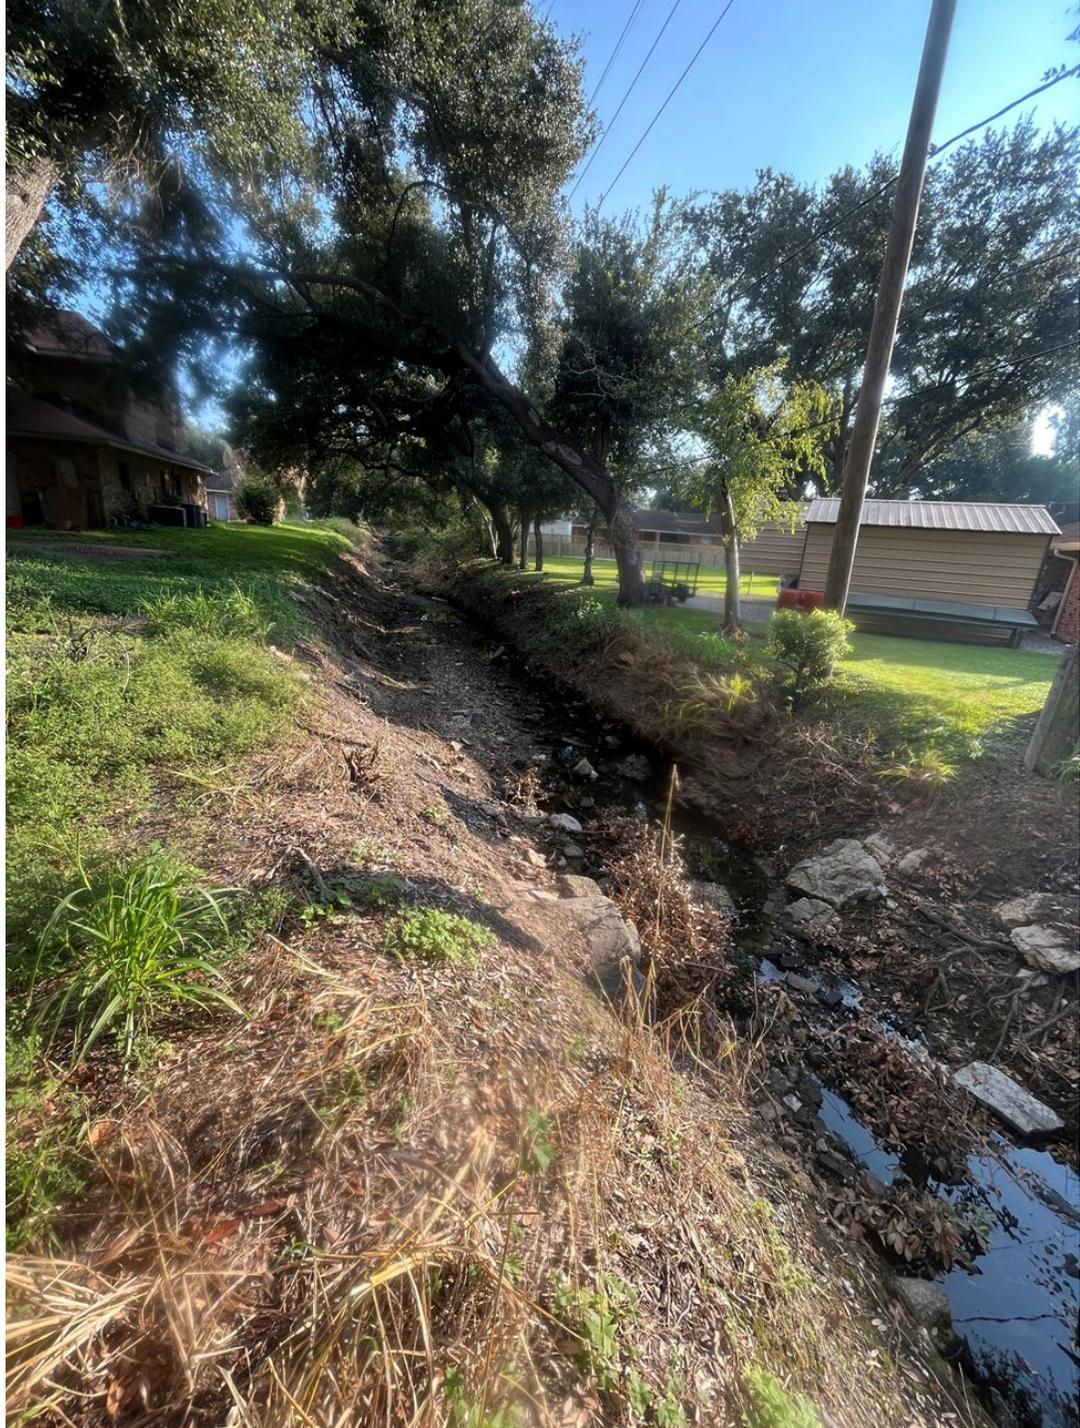
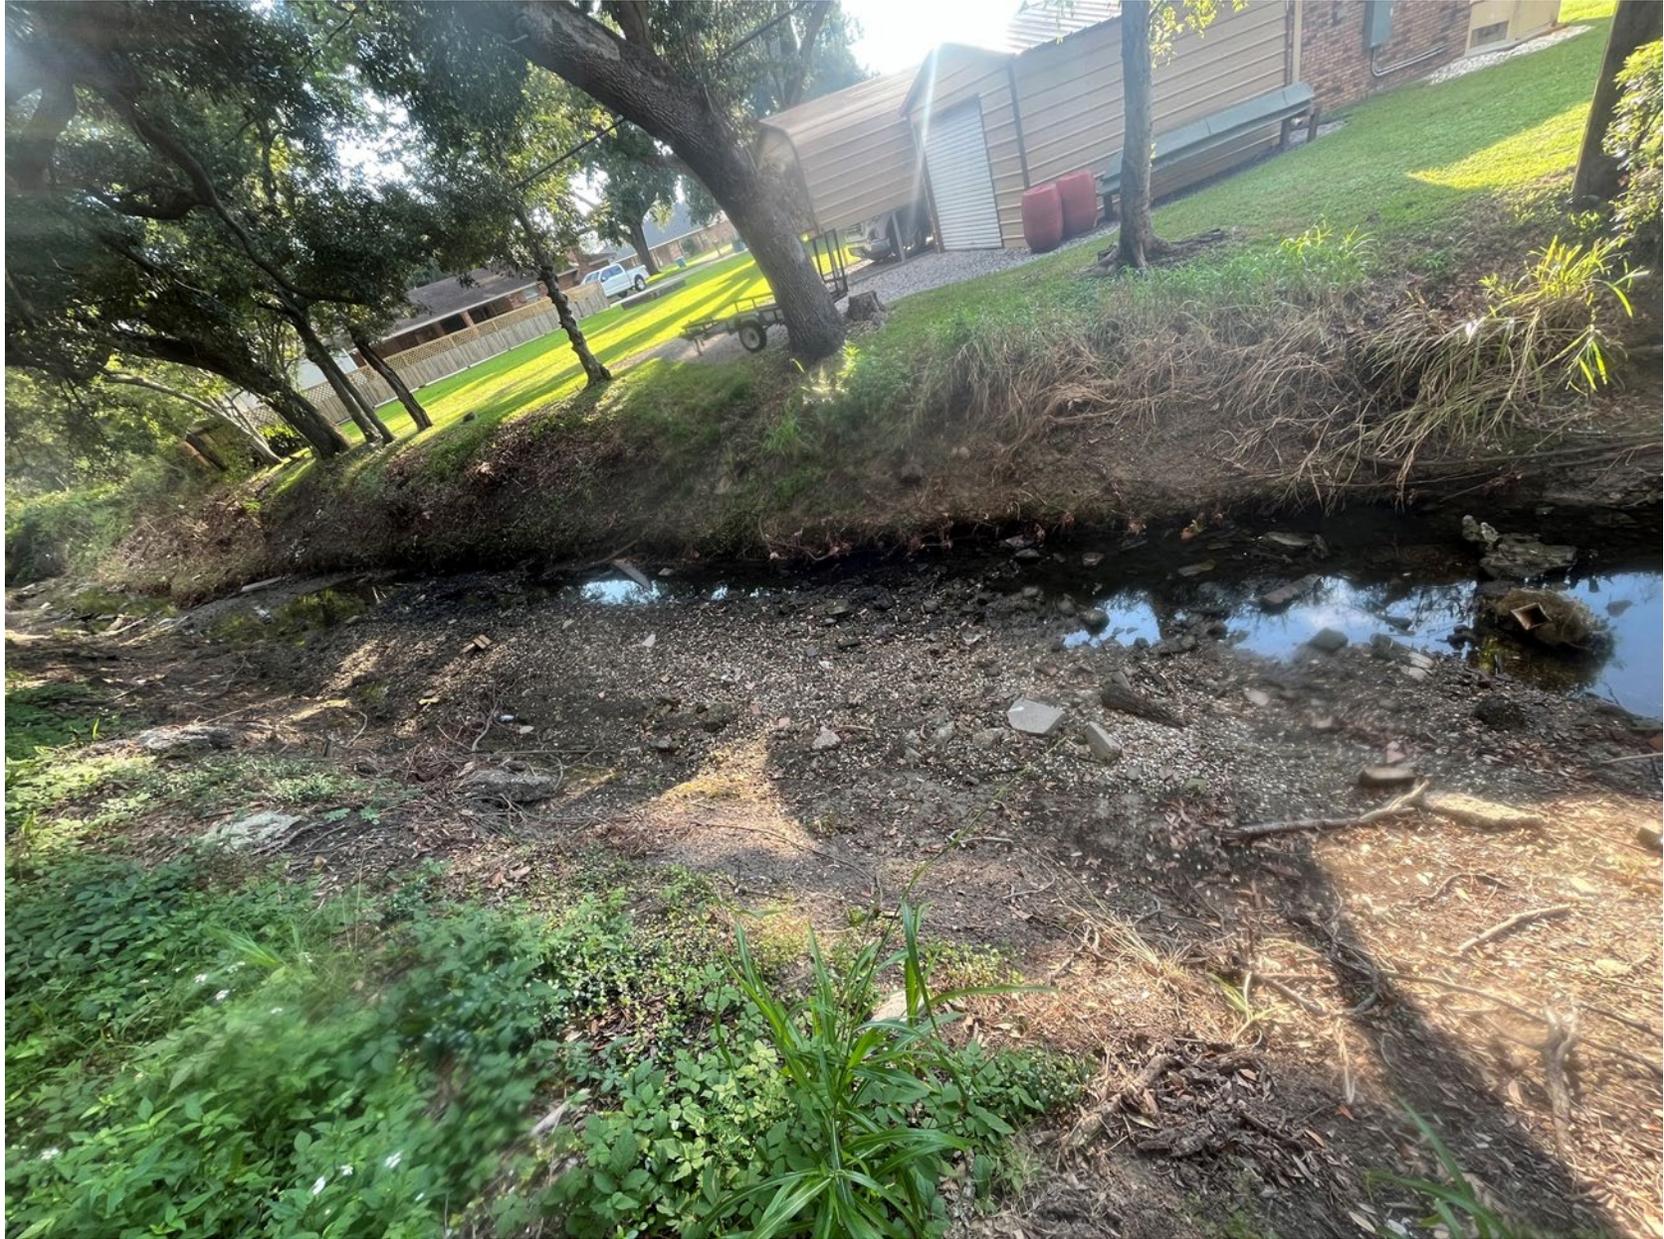
# Ormond Oaks Canal

- Ormond Oaks Canal between Ditch 1 and Hermitage Ct – debris and shoals in canal bottom
- Residents on Ormond Oaks Dr south of Eve St have observed water flowing southward toward River Road when rains begin, then shift northward as rain increases. The shoals cause water from Ditch 1 between Shadow Lane and Hermitage Ct to build up and flow goes uphill until the canal has higher level. Then it flows northward to the headwall at S Beauregard Lane.
- This ditch need to be cleaned out to remove the shoals and debris.

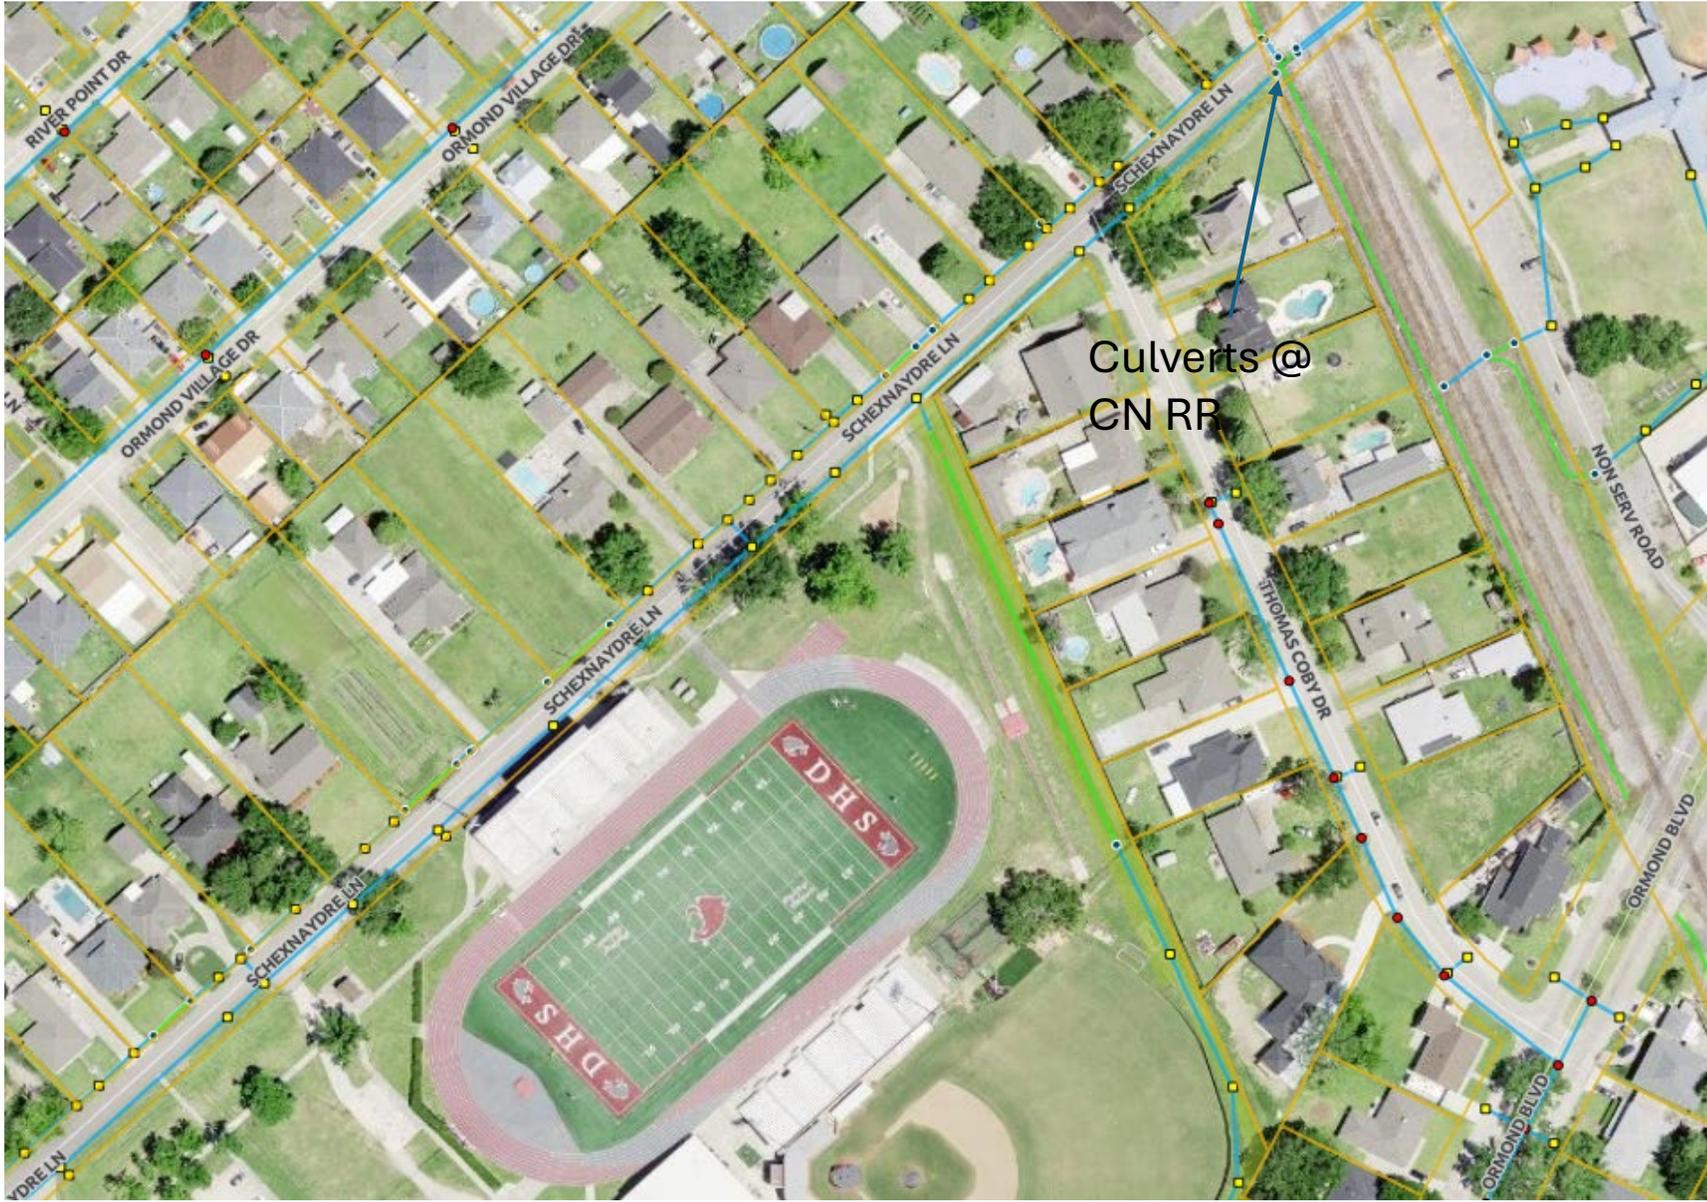
Culverts @  
CN RR

- Schexnaydre Lane culverts across CN RR. Gets clogged debris and cable, but base is being undermined and emergency repair was performed by CN and PW after Ida.
- This set of culverts needs to be replaced with a trestle.
- Main culvert from lane is silted up

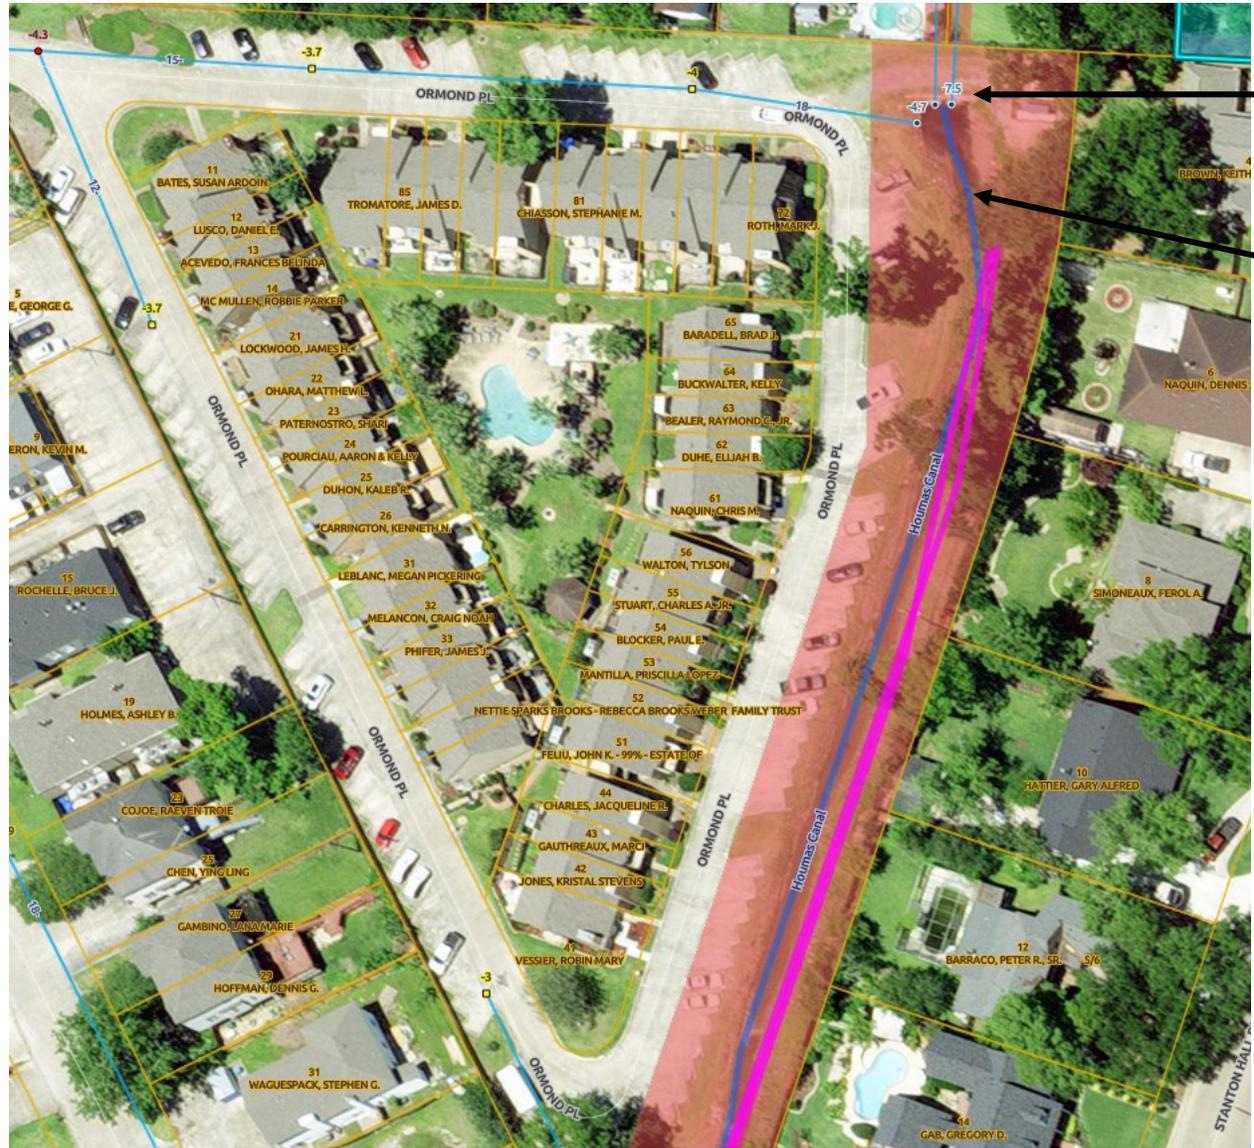
- Ormond Place Condos – Houmas Canal Headwall Culverts over 60% silted in
- Canal near headwall silted in with shoal

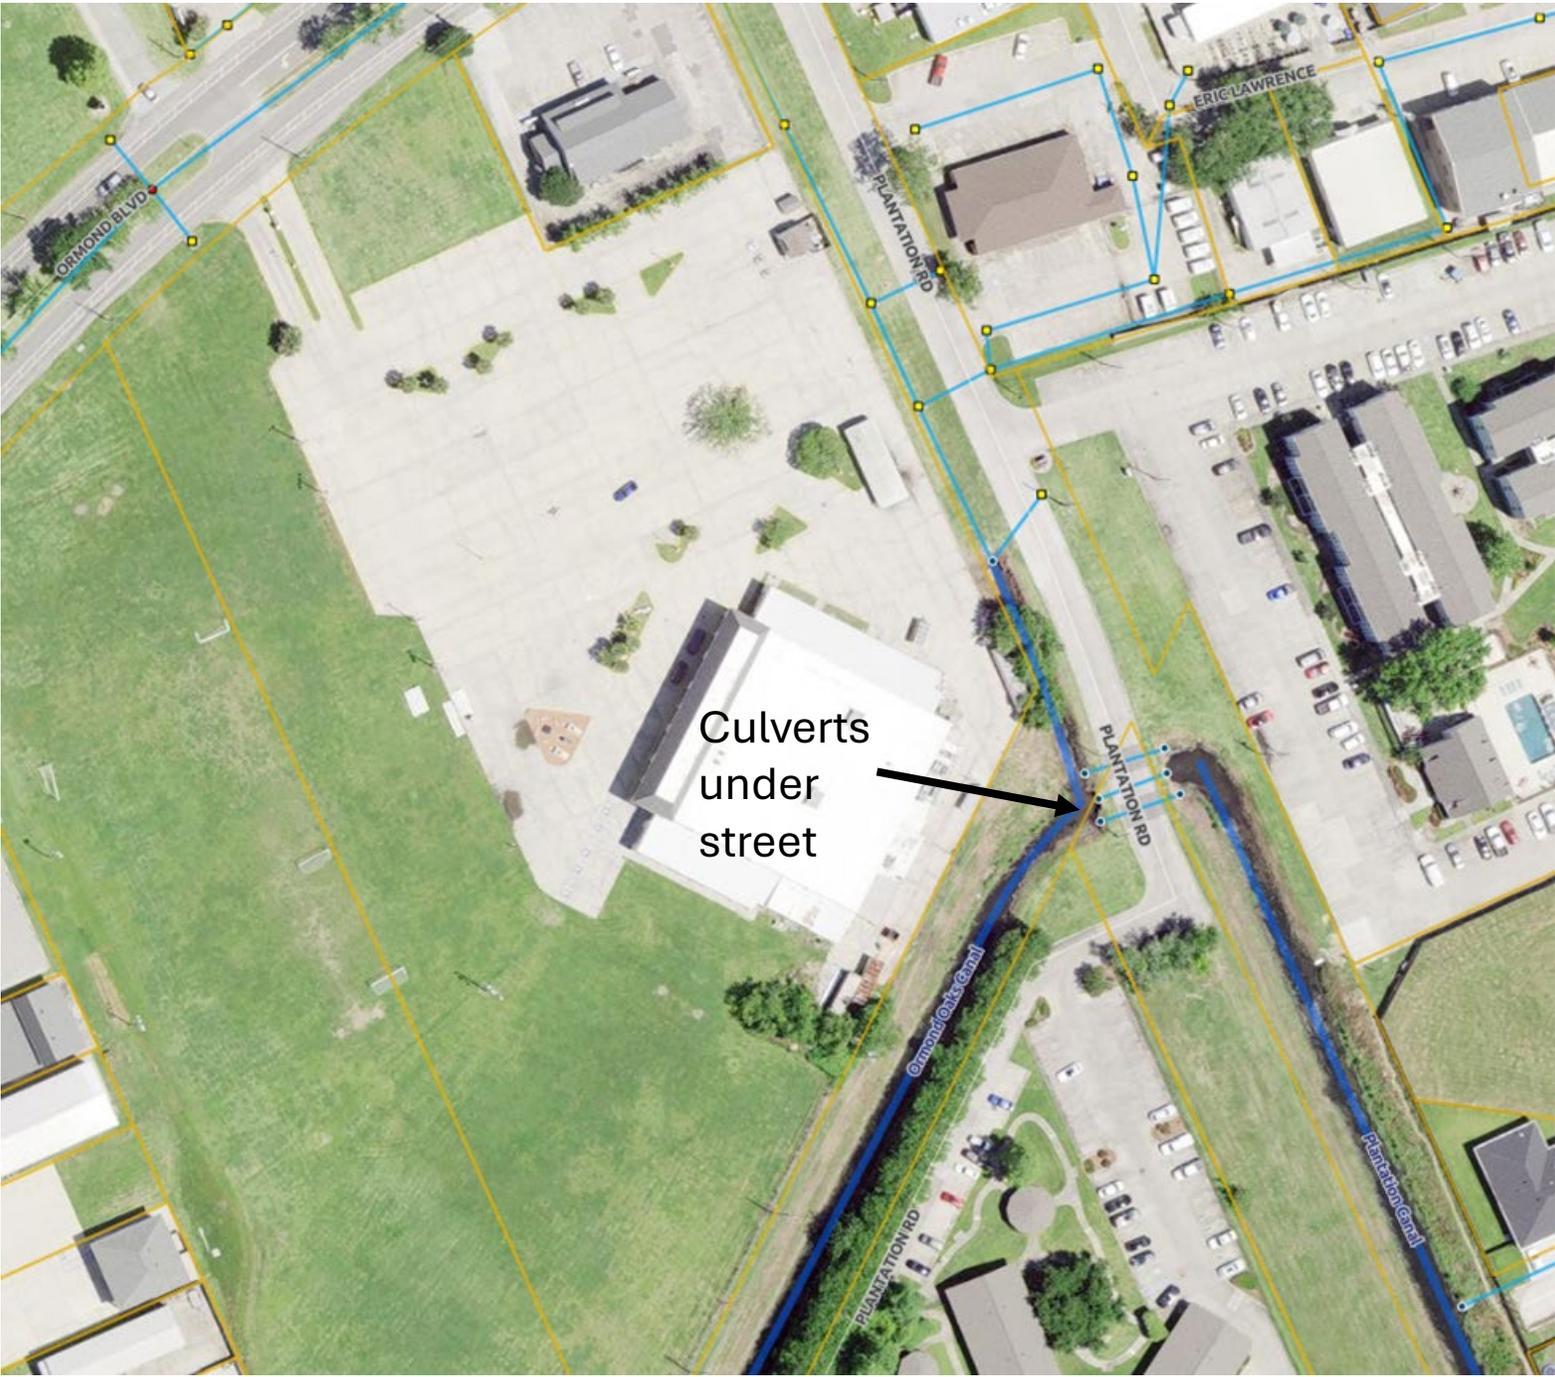
Culverts  
under  
street

- Plantation Road at Nursing Home entrance – right  
60” arched culvert inlet shoaled

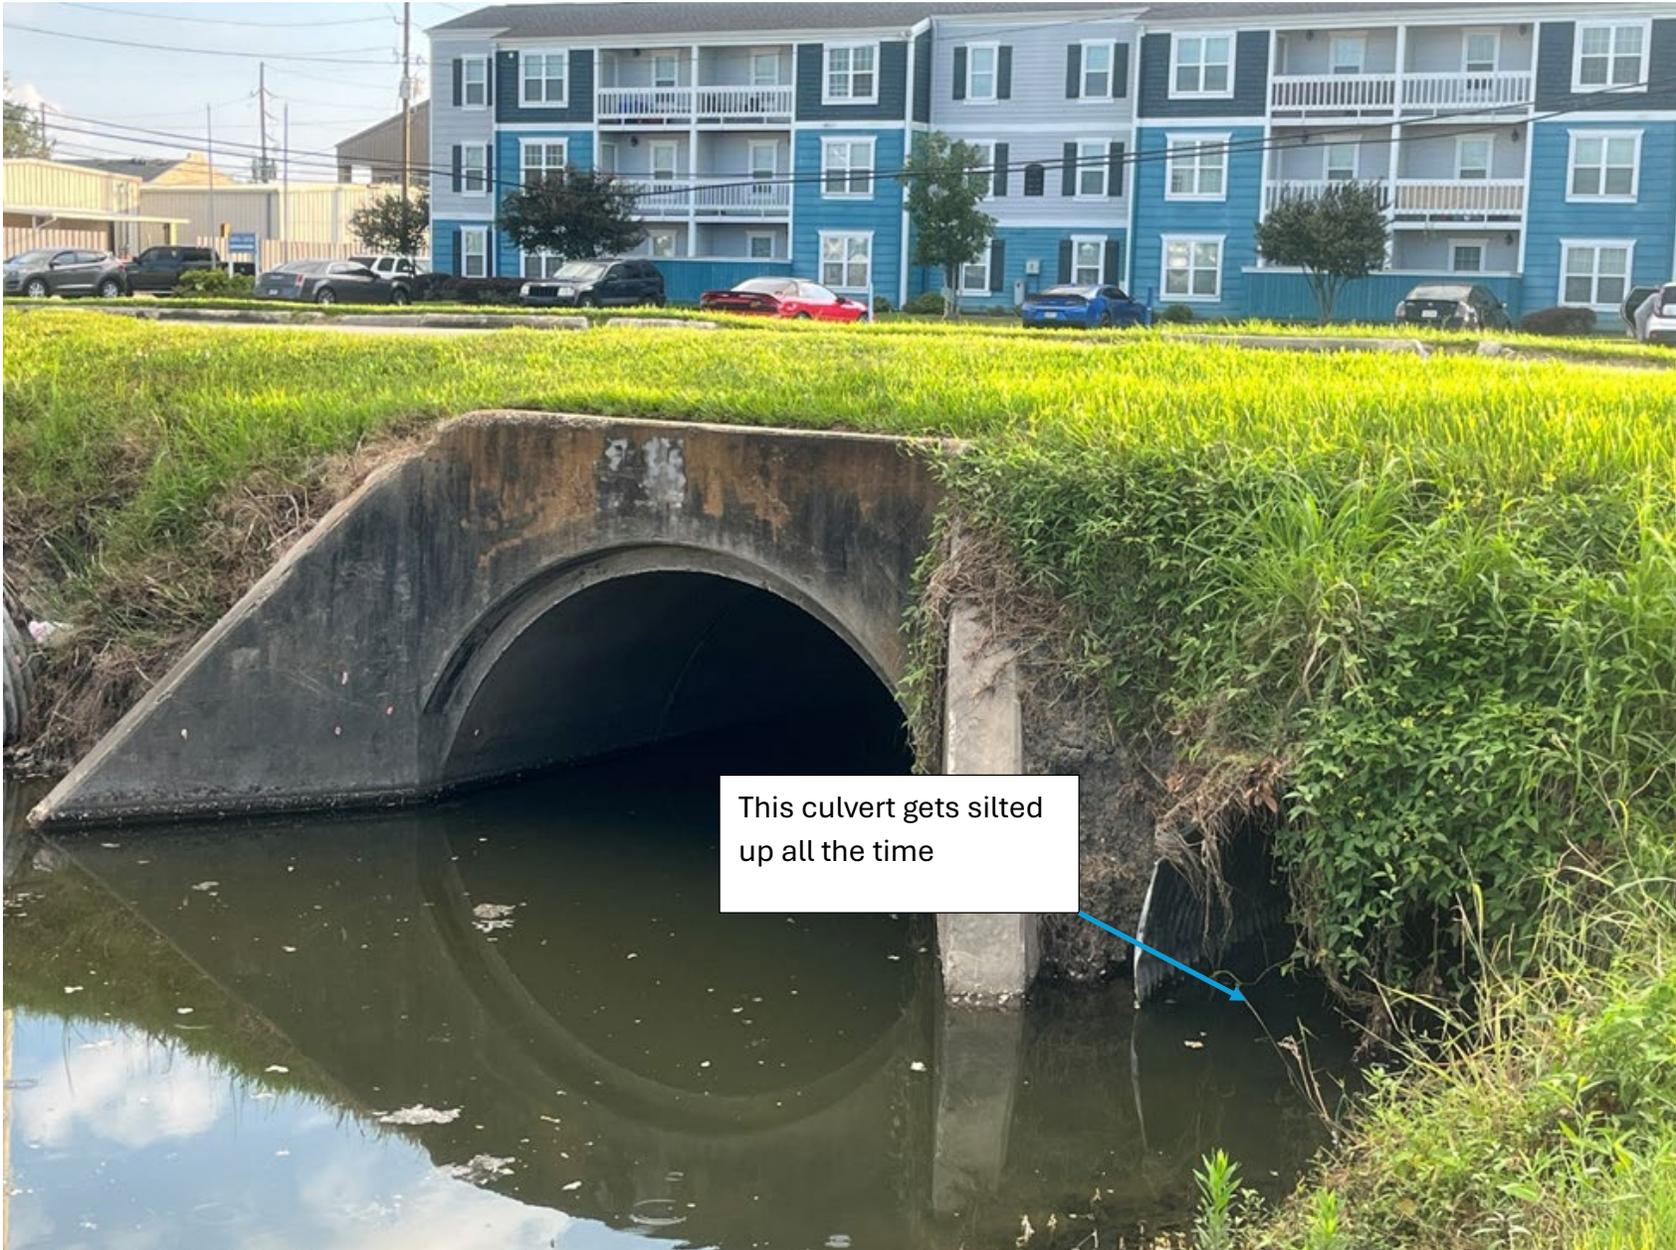
This culvert gets silted up all the time

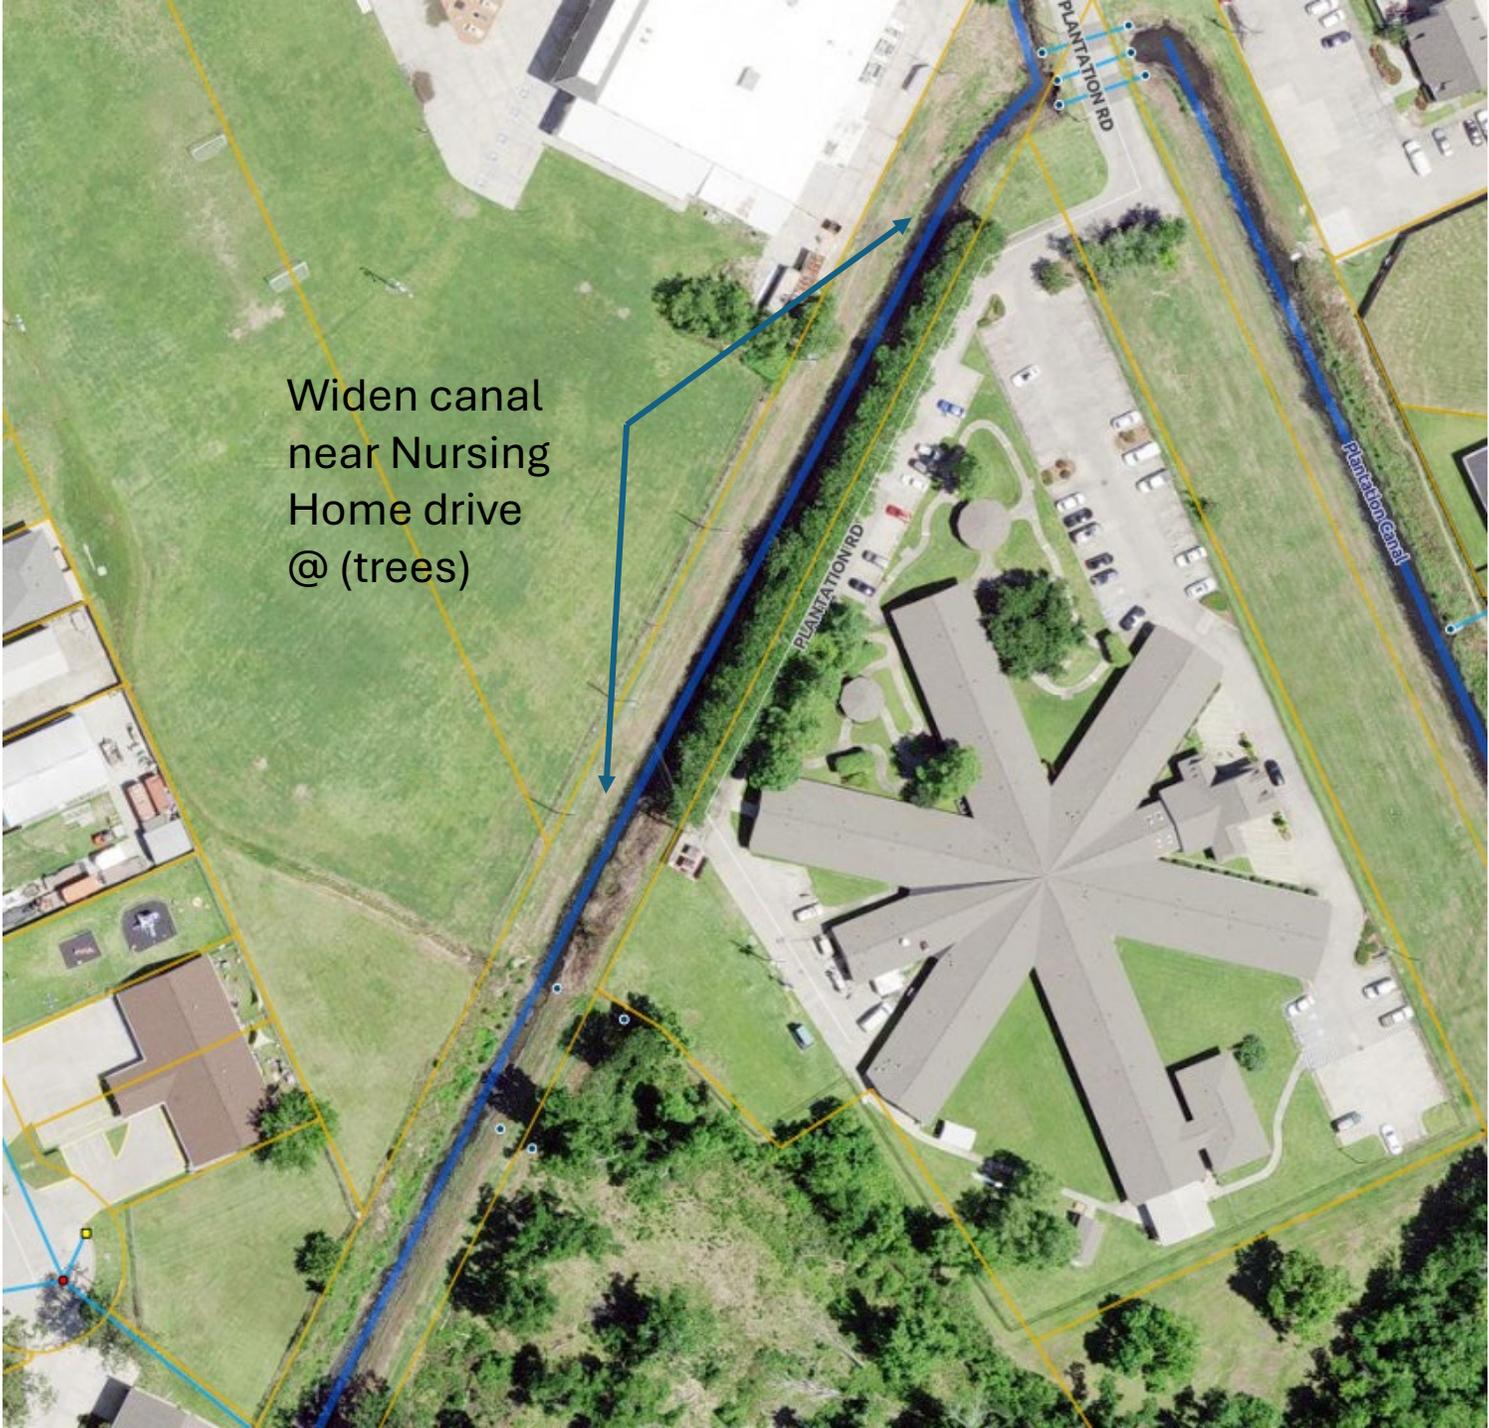
- Canal along Nursing Home was not widened in 2020 – bottleneck removal will reduce level upstream

Widen canal  
near Nursing  
Home drive  
@ (trees)

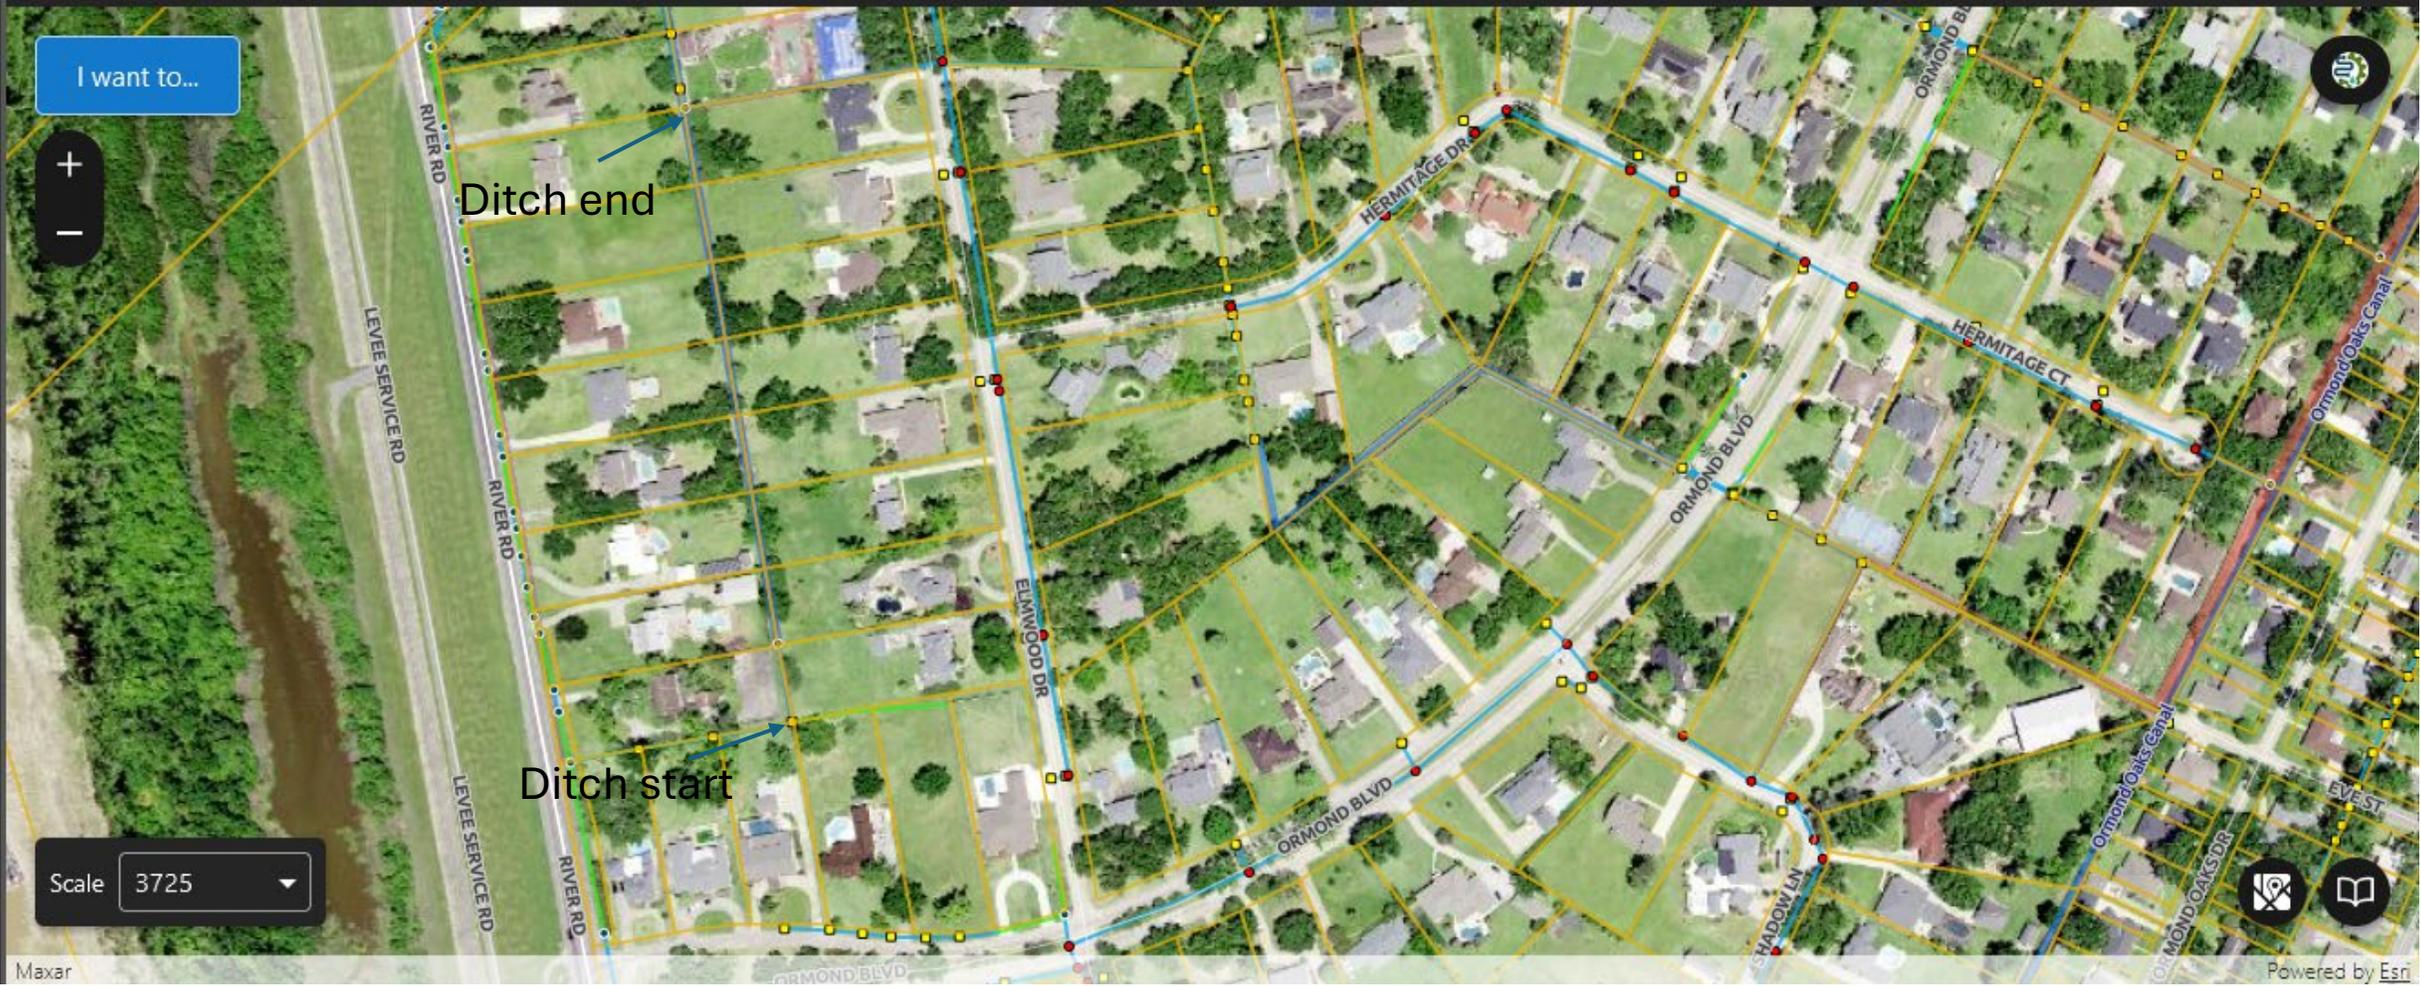
- There is ~ 3 ft drop from lot on Ormond Blvd to culvert
- Water piles up behind homes and floods area
- Residents take extraordinary measures to protect their homes

Resident has had to install berm to protect property
