# District 3 Maintenance Needs

Ormond Oaks Canal

Schexnaydre Lane CN RR culverts

Ormond Place Headwall and Channel

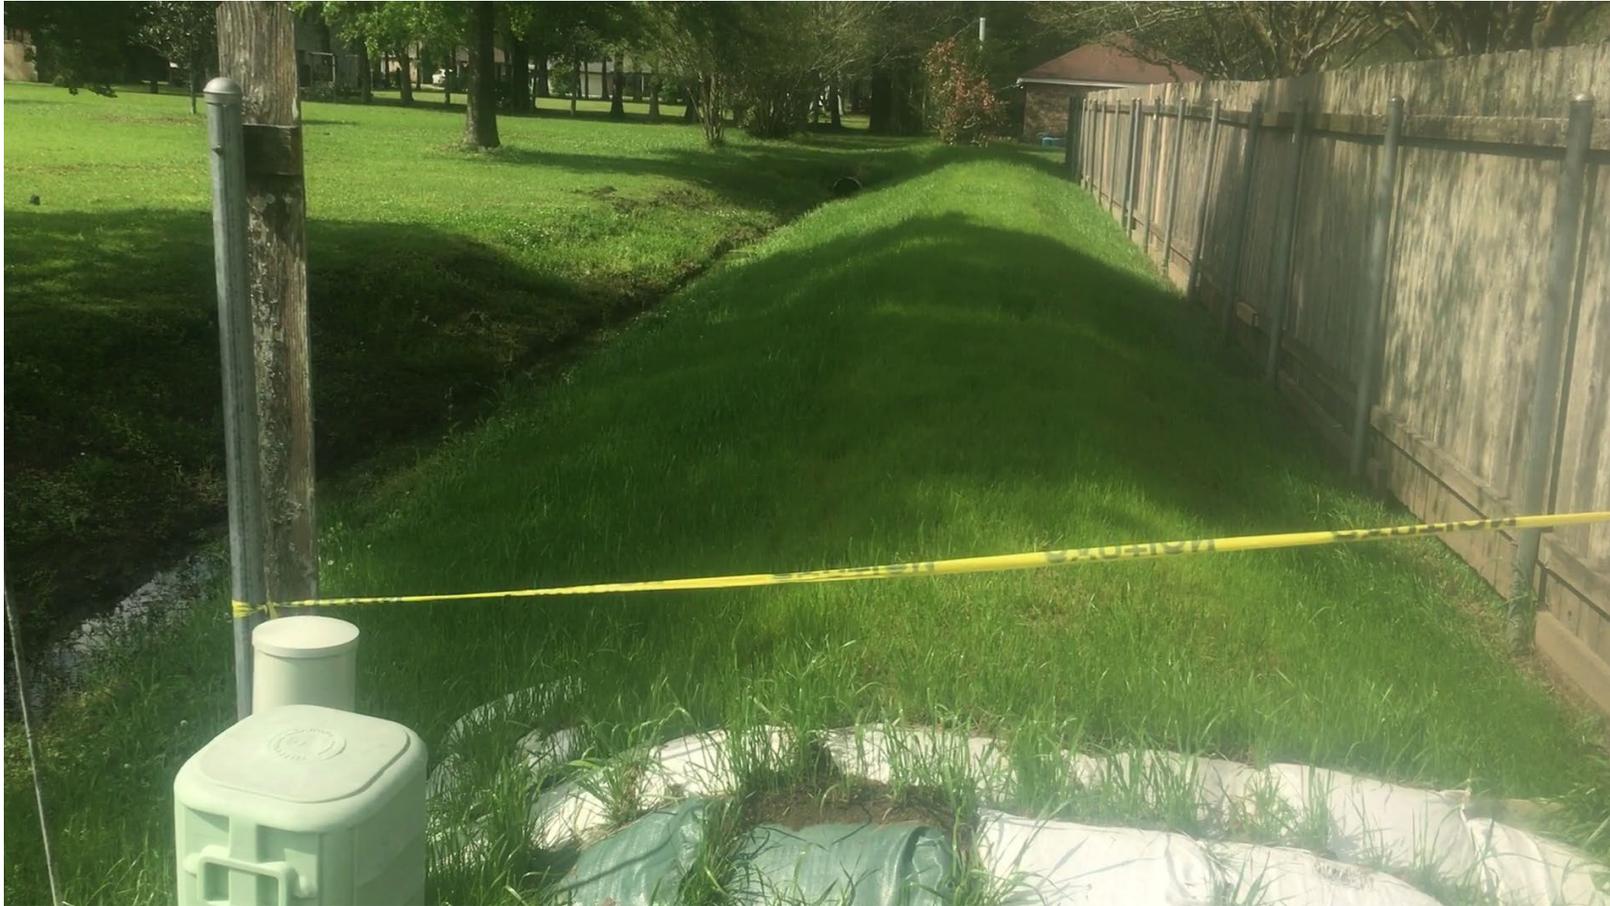
- There is ~ 3 ft drop from lot on Ormond Blvd to culvert
- Water piles up behind homes and floods area
- Residents take extraordinary measures to protect their homes
