CERTIFICATE OF SUBSTANTIAL COMPLETION

Project: Primrose Canal Cleaning & Improvements - Phase 1A

Primrose Canal Cleaning & Improvements Phase 1A Punchlist Walkthrough Items

Walkthrough Date: 7/18/24

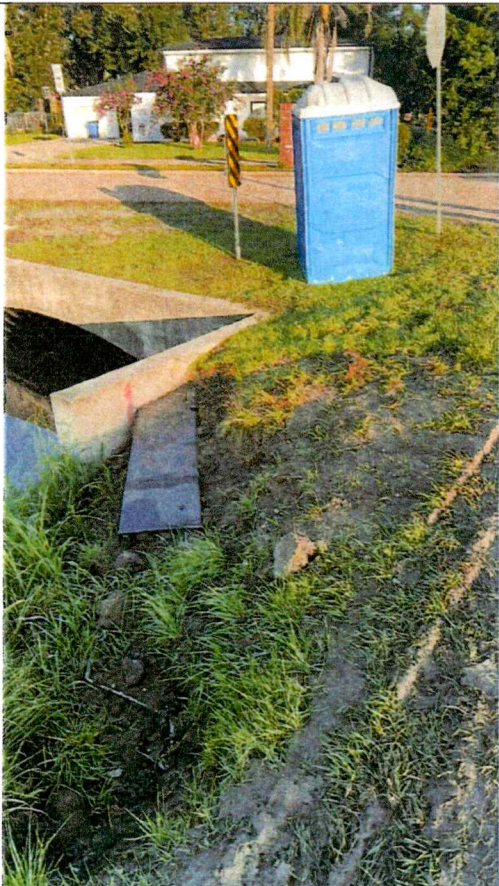
Item No.	Images	Description
1

<p>Station: 105+50 Remarks: Clean up dressing and grading. Install additional channel cap X: -90.355559 Y: 29.89942 Estimated Cost: \$550</p>

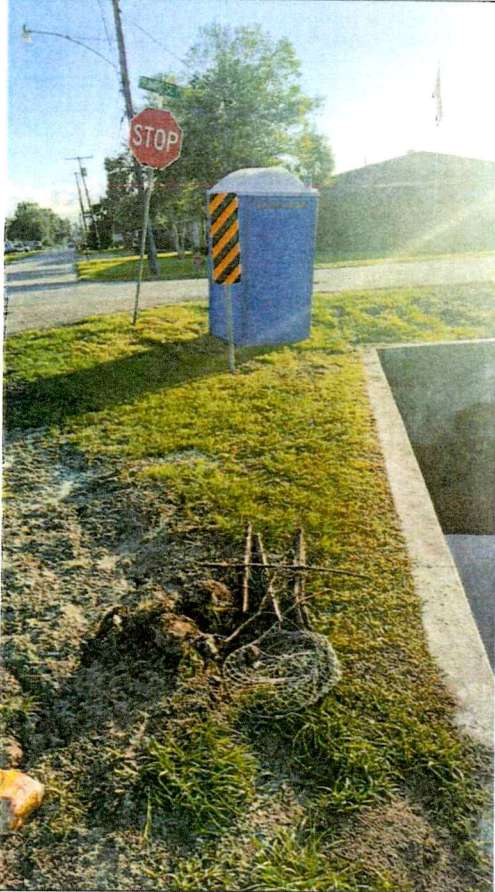
Item No.	Images	Description
2

<p>Station: 105+50 Remarks: Object marker sign and straighten stop sign X: -90.355616 Y: 29.899408 Estimated Cost: \$100</p>

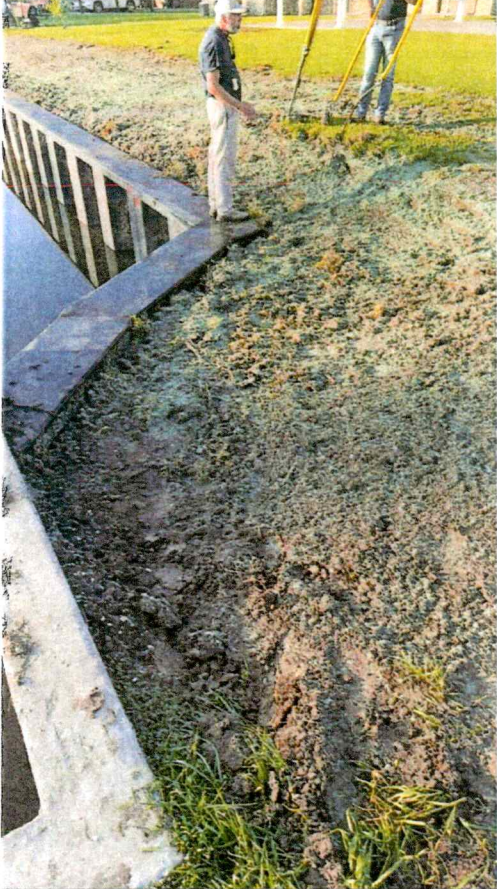
Item No.	Images	Description
3

<p>Station: 105+50 Remarks: Fill in flush to channel cap and grade/seed X: -90.355616 Y: 29.899402 Estimated Cost: \$150</p>

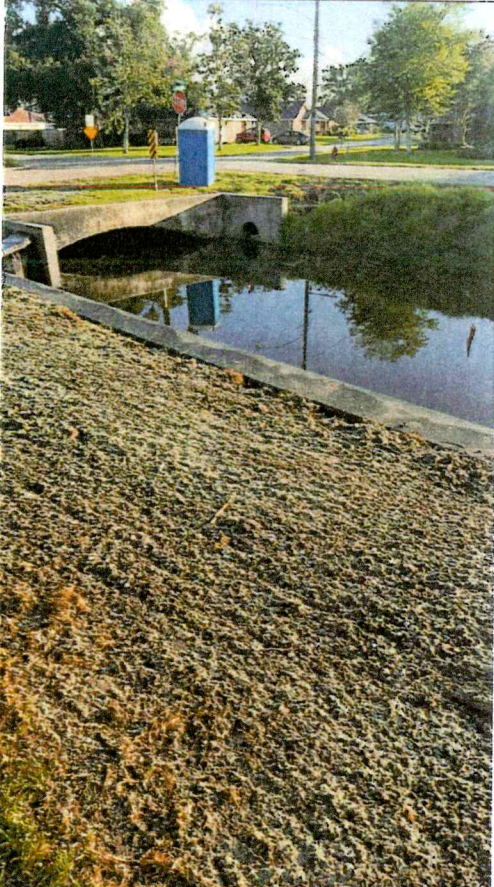
Item No.	Images	Description
4

<p>Station: 105+00 Remarks: Dress up flush to cap X: -90.355527 Y: 29.899237 Estimated Cost: \$25</p>

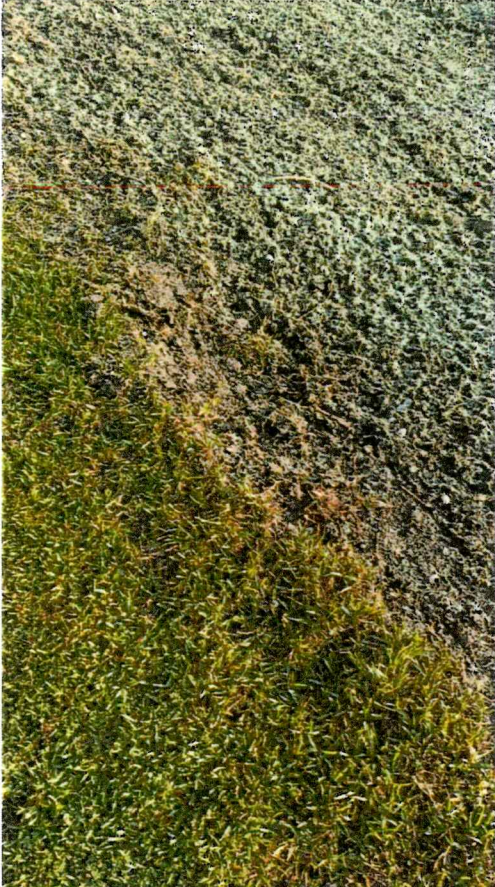
Item No.	Images	Description
5

<p>Station: 104+50 Remarks: Fill in and grade X: -90.355381 Y: 29.899142 Estimated Cost: \$20</p>

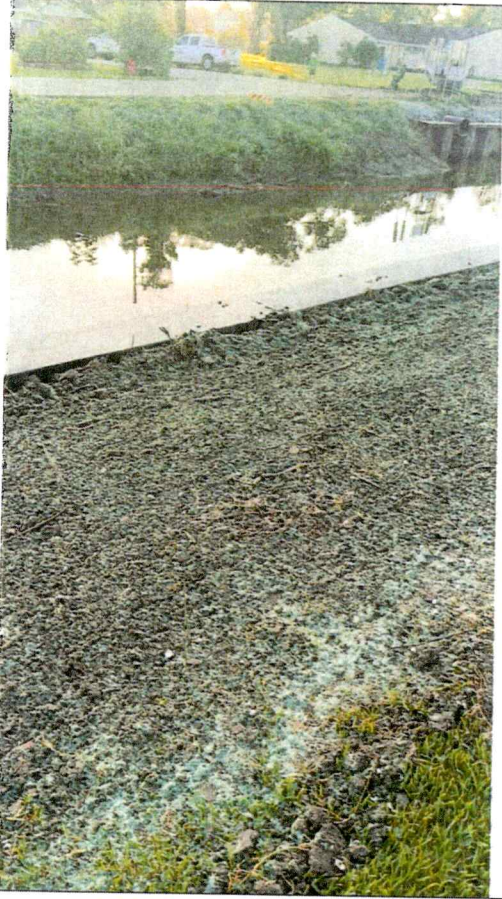
Item No.	Images	Description
6

<p>Station: 104+00 Remarks: Fill and grade to channel cap X: -90.355311 Y: 29.899072 Estimated Cost: \$150</p>

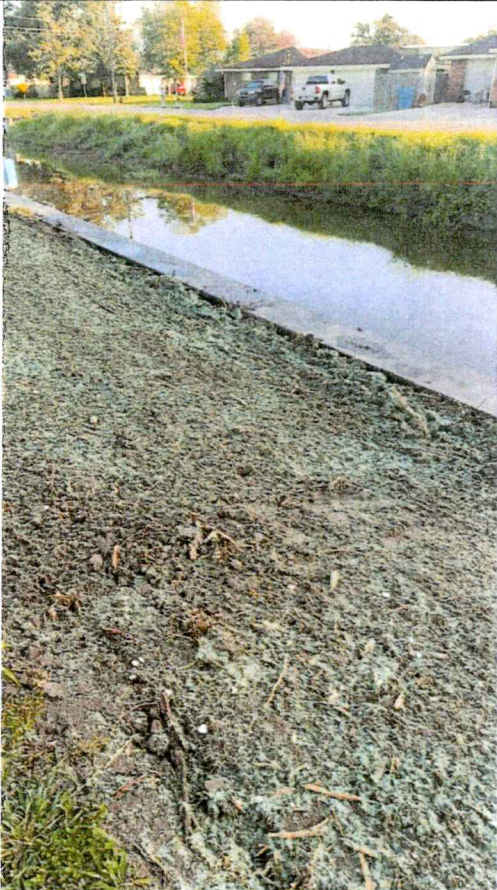
Item No.	Images	Description
7

<p>Station: 104+00 Remarks: Pull roots and debris out of grading X: -90.355257 Y: 29.89904 Estimated Cost: \$100</p>

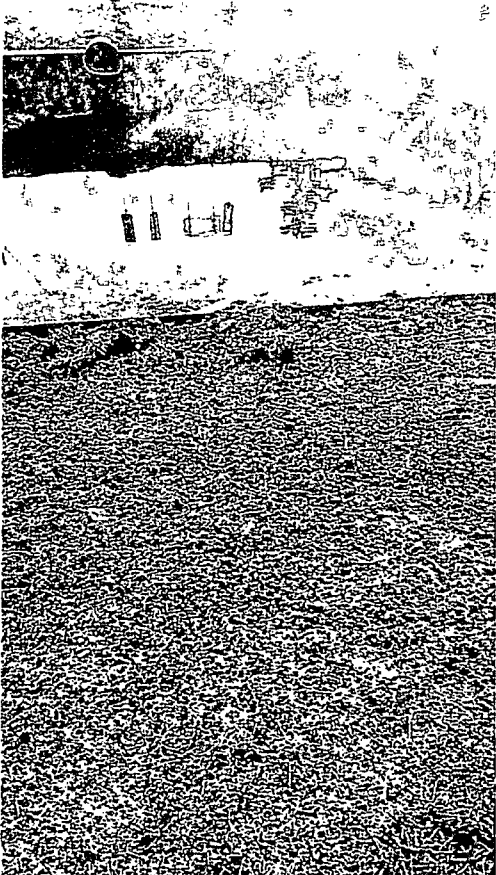
Item No.	Images	Description
8

<p>Station: 103+50 Remarks: Remove clumps X: -90.355117 Y: 29.89892 Estimated Cost: \$100</p>

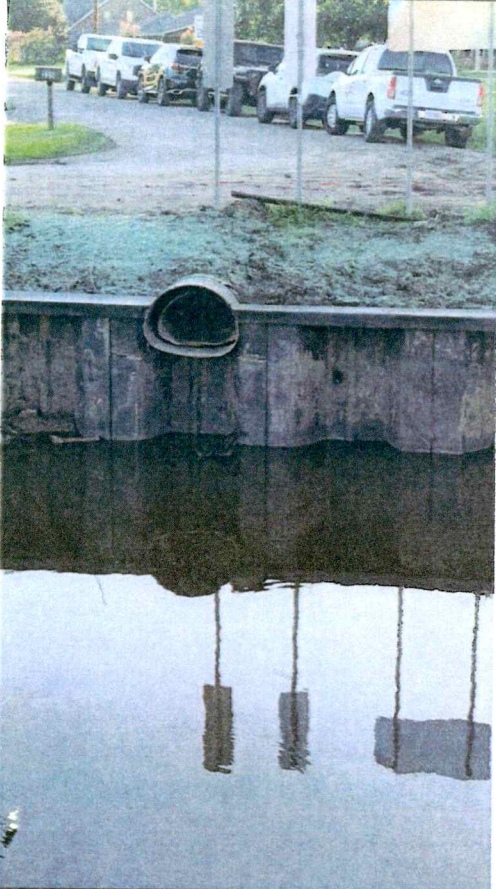
Item No.	Images	Description
9

<p>Station: 103+50 Remarks: Coat sheetpile and exposed metal and welds X: -90.355114 Y: 29.898929 Estimated Cost: \$40</p>

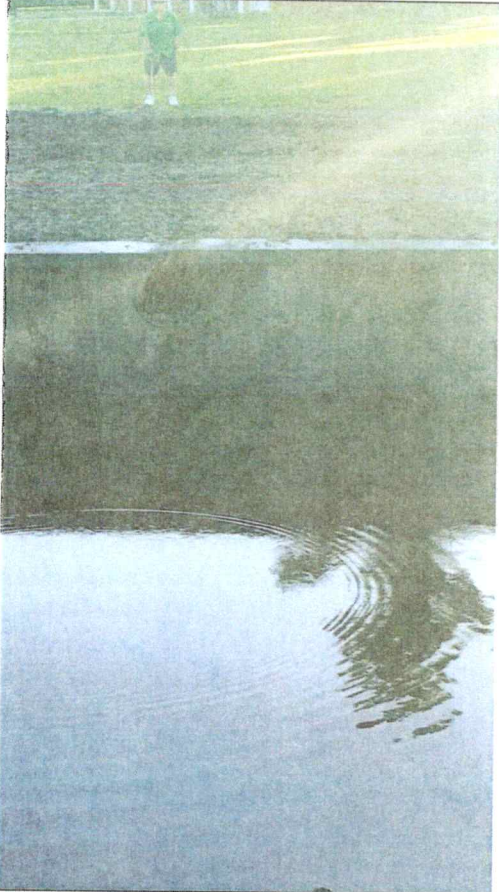
Item No.	Images	Description
10

<p>Station: 103+00 Remarks: Coat sheetpile and exposed metal/welds X: -90.355037 Y: 29.898865 Estimated Cost: \$50</p>

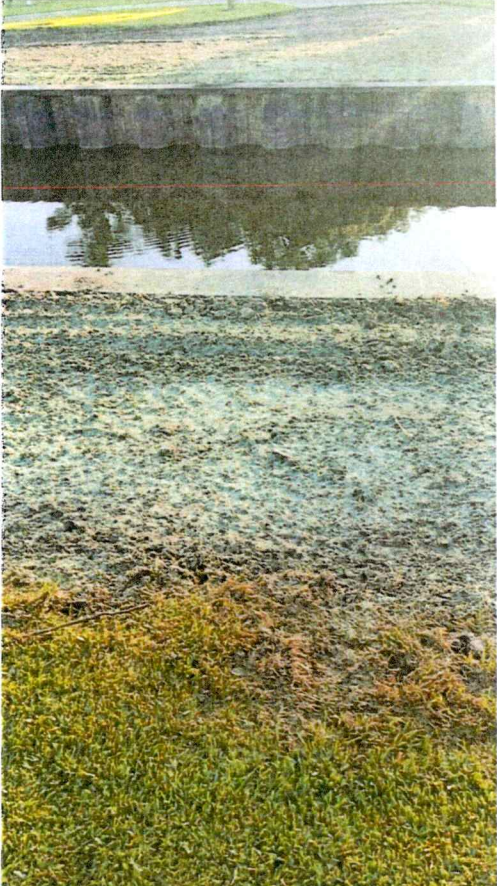
Item No.	Images	Description
11

<p>Station: 102+00 Remarks: Grade to canal cap X: -90.354839 Y: 29.898688 Estimated Cost: \$35</p>

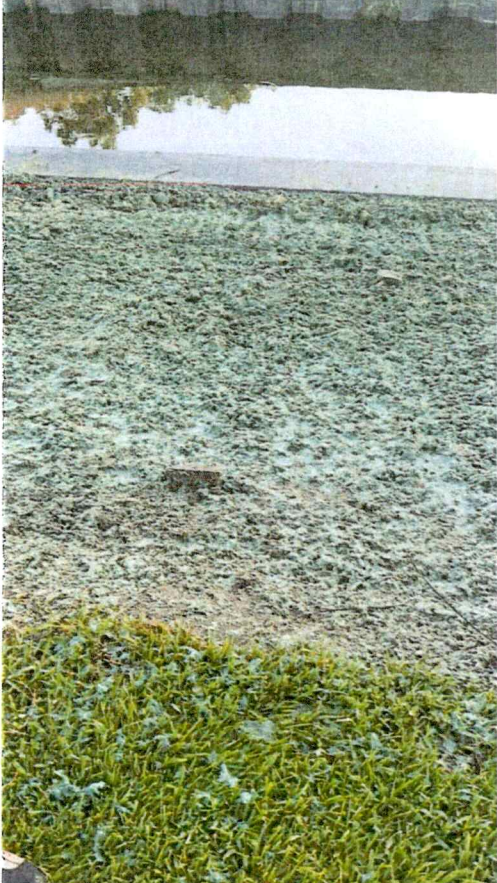
Item No.	Images	Description
13

<p>Station: 101+50 Remarks: Remove debris from grading (applies to whole site) X: -90.354653 Y: 29.898543 Estimated Cost: \$150</p>

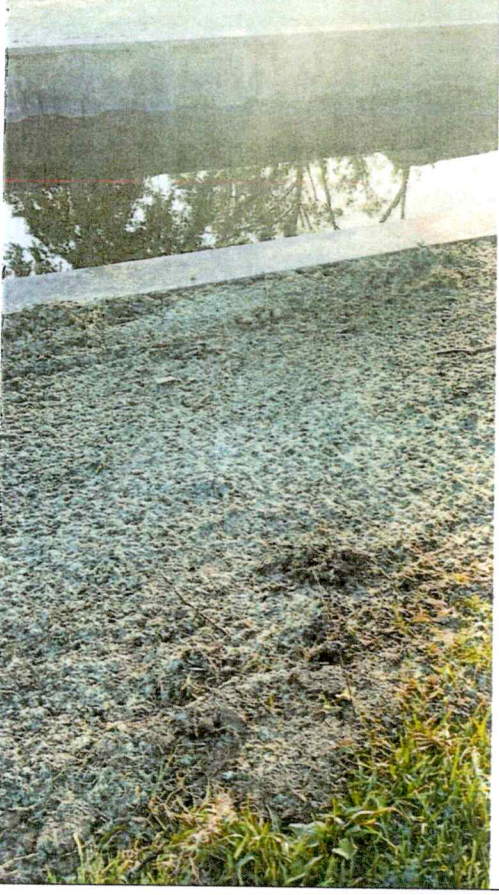
Item No.	Images	Description
14

<p>Station: 101+00 Remarks: Brick removal X: -90.354564 Y: 29.898483 Estimated Cost: \$15</p>

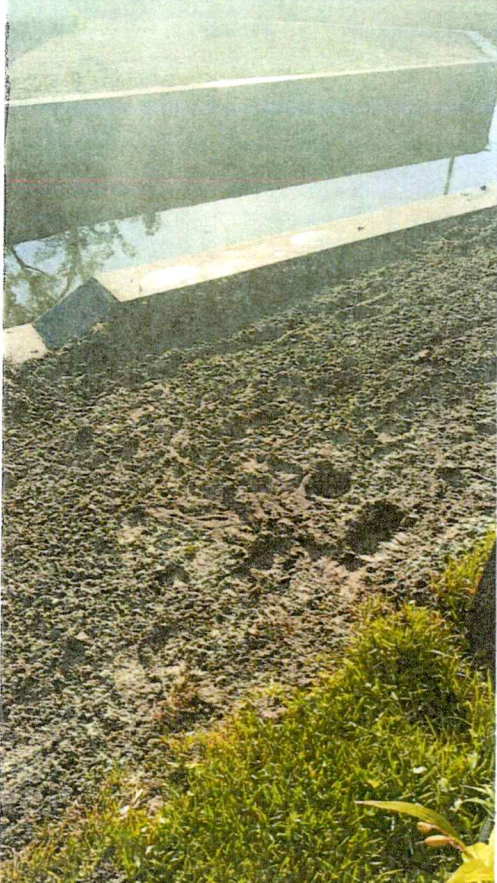
Item No.	Images	Description
15

<p>Station: 100+50 Remarks: Grade and seed to channel cap X: -90.354443 Y: 29.898395 Estimated Cost: \$60</p>

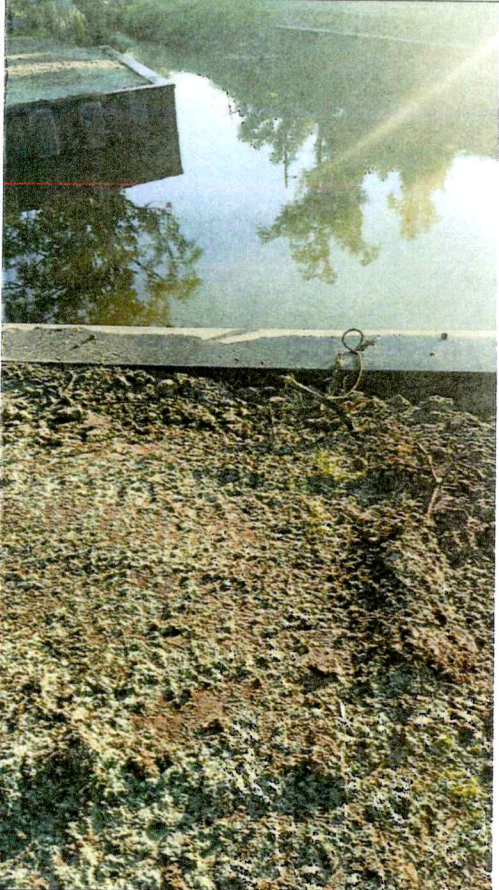
Item No.	Images	Description
16

<p>Station: 100+00 Remarks: Remove debris X: -90.354212 Y: 29.898208 Estimated Cost: \$30</p>

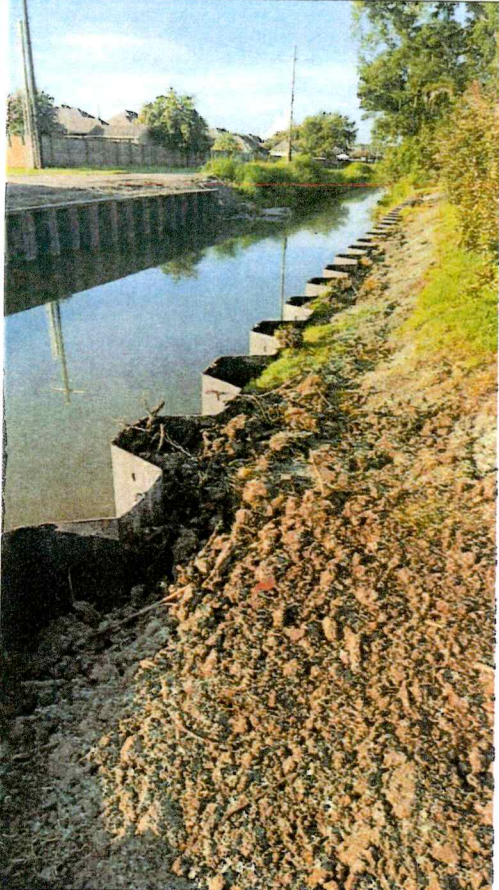
Item No.	Images	Description
17

<p>Station: 100+00 Remarks: Channel cap and free draining aggregate/weepholes X: -90.354182 Y: 29.898228 Estimated Cost: \$5,000</p>

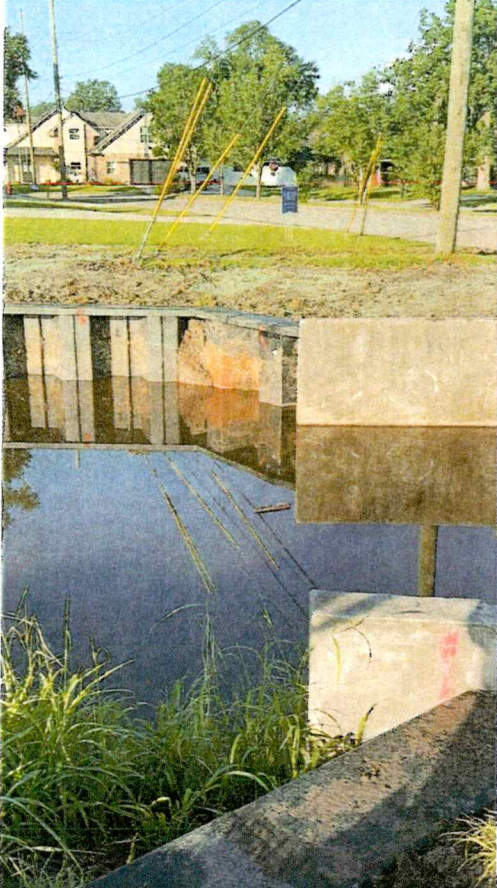
Item No.	Images	Description
18

<p>Station: 105+50 Remarks: Paint sheetpile and exposed metal X: -90.355509 Y: 29.899459 Estimated Cost: \$120</p>

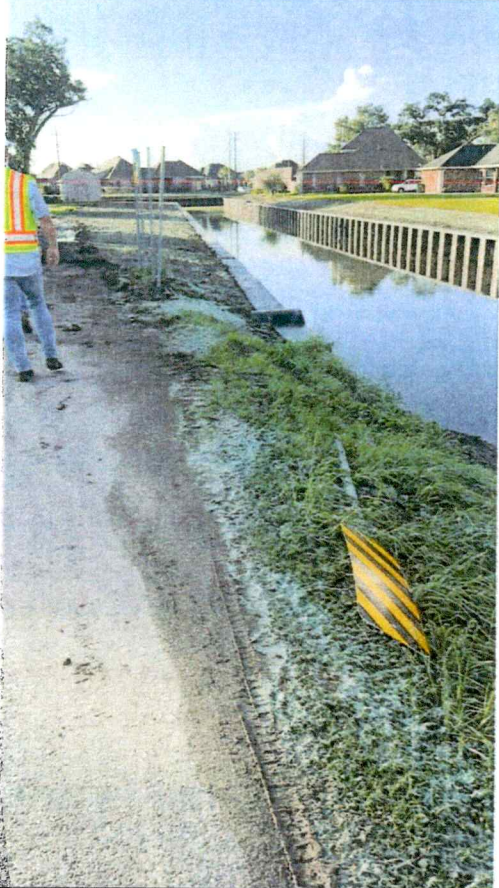
Item No.	Images	Description
19

<p>Station: 103+50 Remarks: Straighten signs and reinstall X: -90.355069 Y: 29.899122 Estimated Cost: \$100</p>

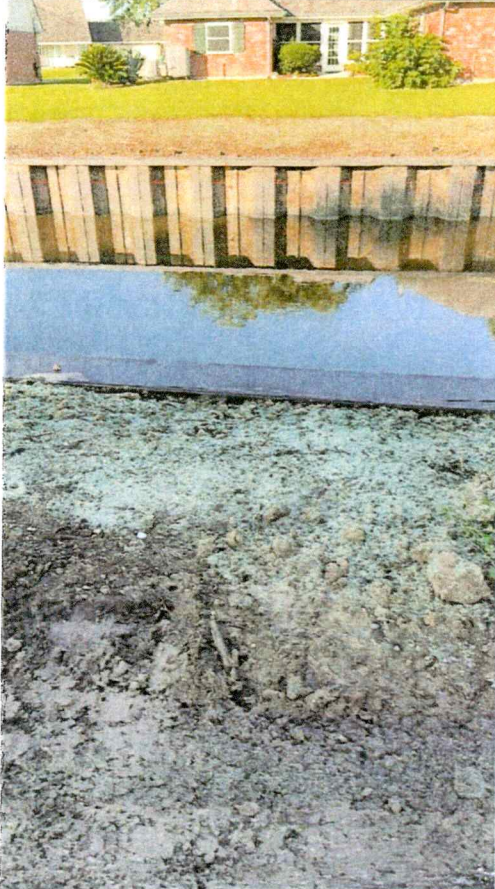
Item No.	Images	Description
20

<p>Station: 103+00 Remarks: Grade to channel cap X: -90.354945 Y: 29.899033 Estimated Cost: \$200</p>

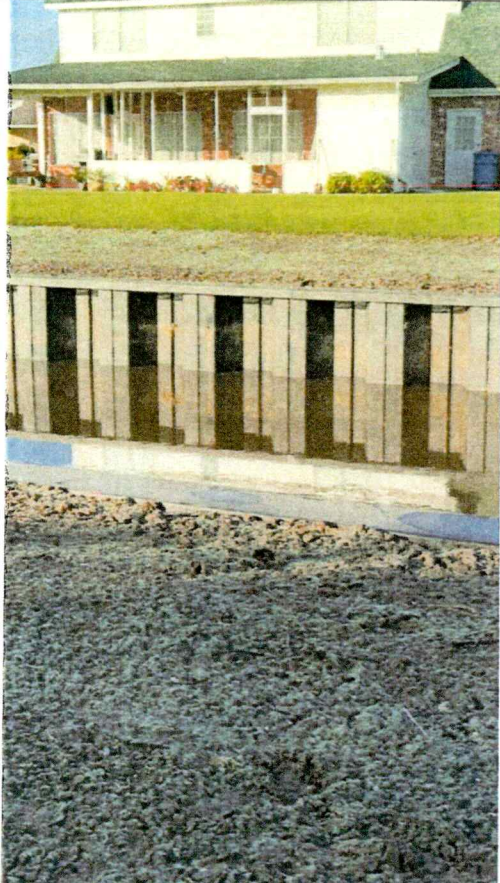
Item No.	Images	Description
21

<p>Station: 103+00 Remarks: Coat weepholes and exposed metal X: -90.354864 Y: 29.898984 Estimated Cost: \$150</p>

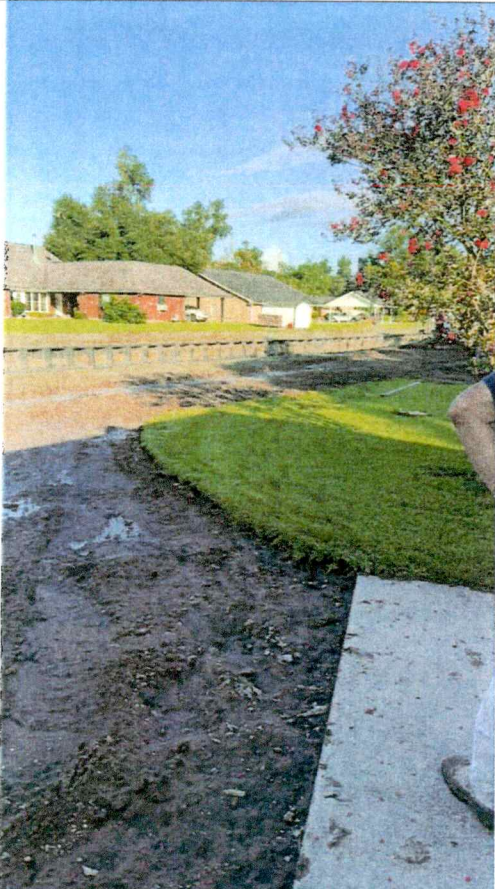
Item No.	Images	Description
22

<p>Station: 102+50 Remarks: Driveway and sod yard are areas surrounding driveway X: -90.354702 Y: 29.898931 Estimated Cost: \$23,250</p>

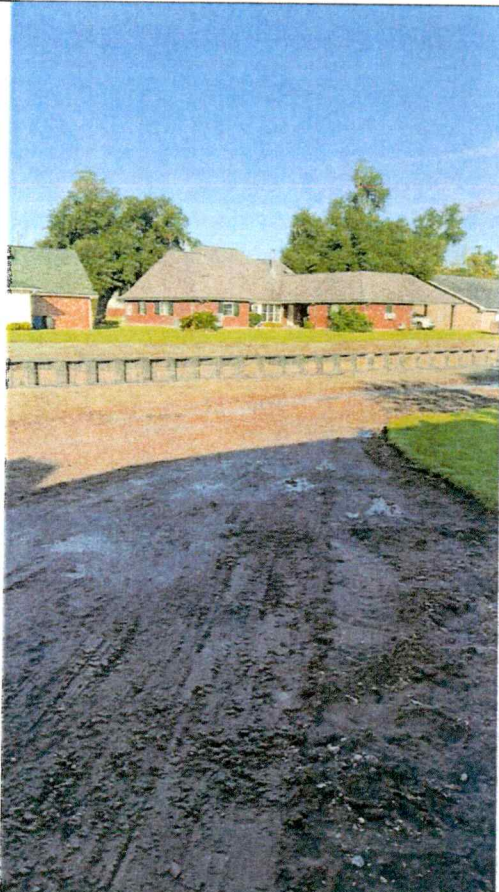
Item No.	Images	Description
23

<p>Station: 102+00 Remarks: Grade to channel cap and seed X: -90.354576 Y: 29.898912 Estimated Cost: \$200</p>

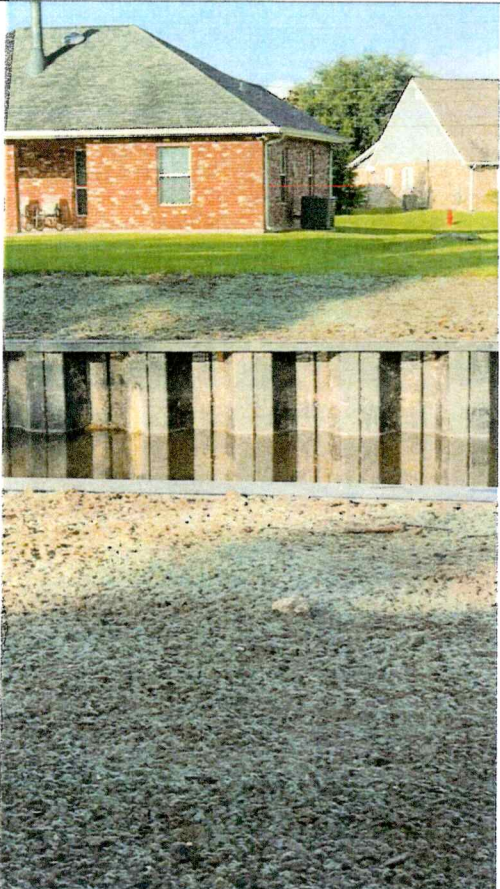
Item No.	Images	Description
24

<p>Station: 102+00 Remarks: Coat exposed metal rust stains forming X: -90.354603 Y: 29.898813 Estimated Cost: \$25</p>

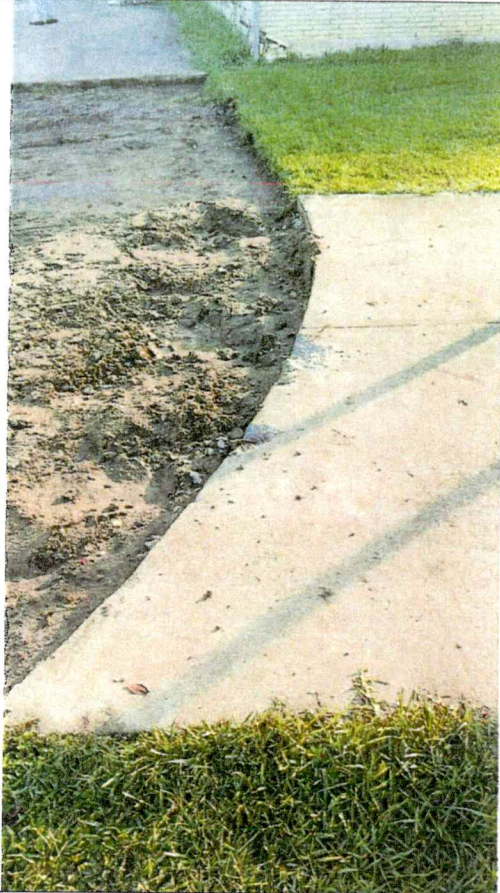
Item No.	Images	Description
25

<p>Station: 102+00 Remarks: Repair cracked driveway. CHF recommends sawcut past joint approximately 1 foot X: -90.354598 Y: 29.898829 Estimated Cost: \$300</p>

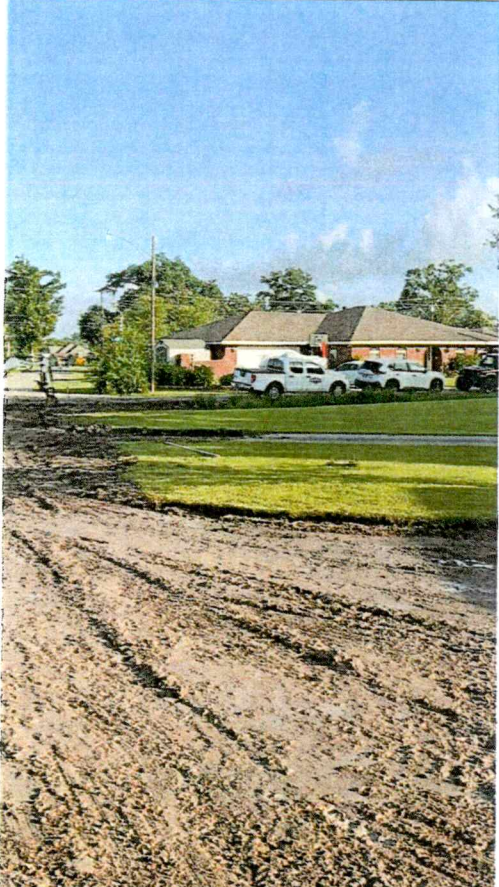
Item No.	Images	Description
26

<p>Station: 102+00 Remarks: Install temporary driveway X: -90.354598 Y: 29.89883 Estimated Cost: \$1,200</p>

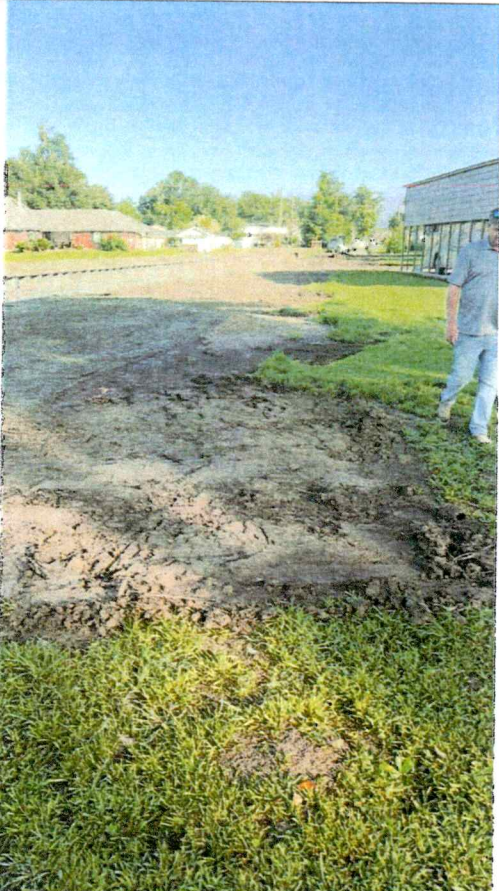
Item No.	Images	Description
27

<p>Station: 101+50 Remarks: Sod grass outside of silt fence servitude X: -90.354425 Y: 29.898746 Estimated Cost: \$250</p>

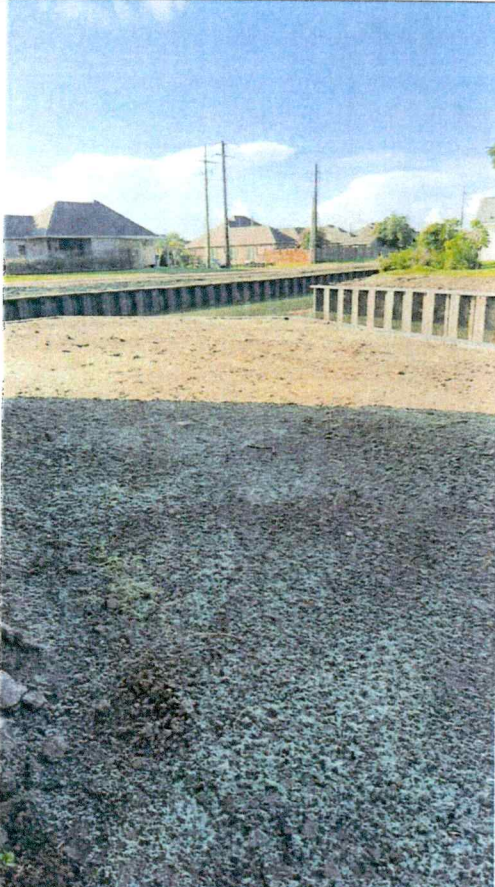
Item No.	Images	Description
28

<p>Station: 100+50 Remarks: Remove debris from graded area X: -90.354286 Y: 29.898551 Estimated Cost: \$50</p>

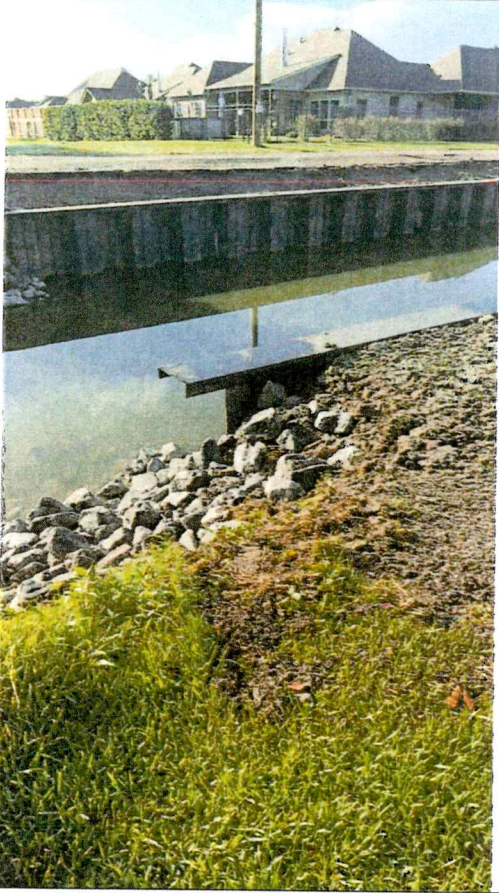
Item No.	Images	Description
29

<p>Station: 100+00 Remarks: Cut to sheetpile length X: -90.354092 Y: 29.898579 Estimated Cost: \$150</p>

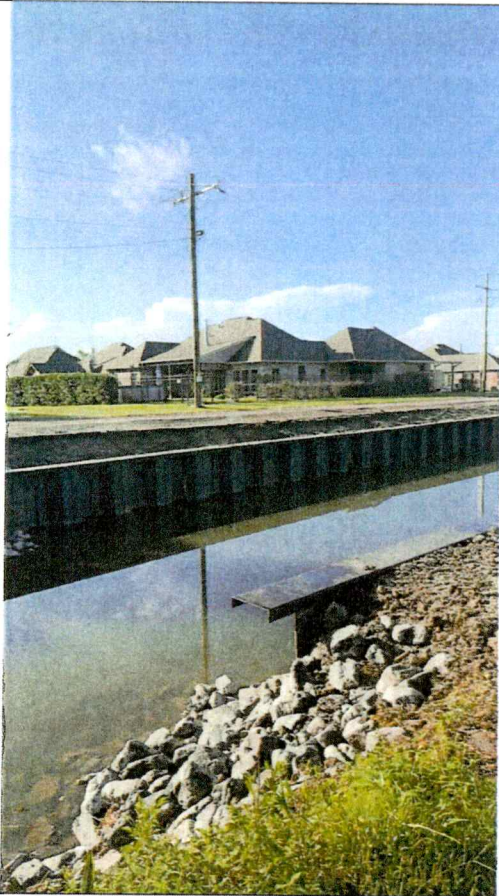
Item No.	Images	Description
30

<p>Station: 100+00 Remarks: Coat exposed metal along Texaco road X: -90.354094 Y: 29.898582 Estimated Cost: \$150</p>

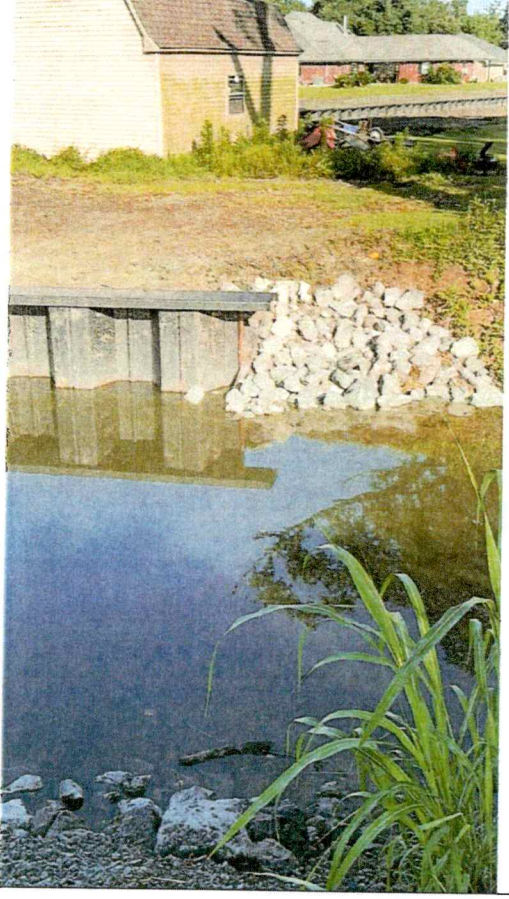
Item No.	Images	Description
31

<p>Station: 100+00 Remarks: Coat exposed metal X: -90.353926 Y: 29.898531 Estimated Cost: \$20</p>
